# Road Safety Audit Report

**Incorporating  
Stage 1 Completion of Preliminary Design; and  
Design Organisation Response to items raised.**

## **Proposed Access off and Highway works along the B2102, Bird in Eye Hill in Uckfield**

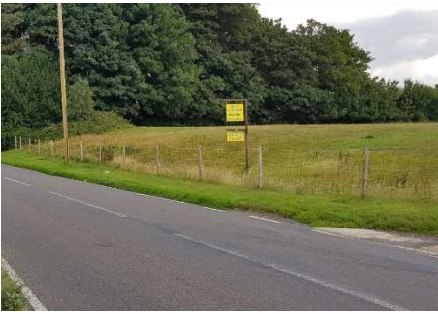
| <b>Location:</b> | Proposed access |
| <b>Summary:</b> | Vehicles may approach Bird in Eye Hill at inappropriate speeds |
| <p>The application site is currently set at a level above the adjacent Bird in Eye Hill with the existing access rising gradually away from the main carriageway. The proposals relocate the existing access to Bird in Eye Farm in order to serve a proposed development of 300 residential dwellings as well as two existing dwellings outside of the application site. The scheme drawings do not identify the gradient of the proposed carriageway at this stage, however, the land in proximity appears to be approximately 2 to 2.5 metres higher than the level of the existing carriageway. A gradient in excess of 1 in 20 on approach to a simple priority access could lead to junction overshoot type incidents.</p> | |

| It is recommended that the access road is set at a gradient shallower than 1 in 20 on approach to the B2102. | |
| <p>The proposed access will be designed with 1 in 20 or slacker gradient than in accordance with standards with the land either side, graded up away from the carriageway at an appropriate gradient.</p> | |

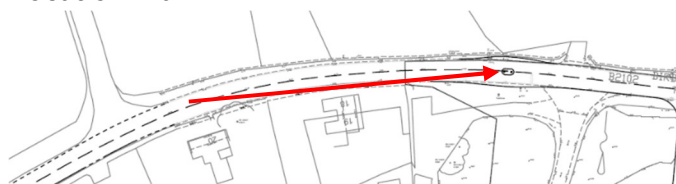
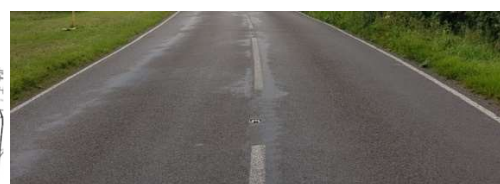
#### Location Plan:

| <b>Location:</b> | Bird in Eye Hill |
| <b>Summary:</b> | Drivers approaching the proposed traffic island may not become aware of the feature at a safe distance |
| <p>In proximity of the proposed access, Bird in Eye Hill is derestricted, subject to the 60 mph national speed limit and accommodates a number of bends in proximity of the proposed access. The</p> | |

proposals that are subject to this Stage 1 Road Safety Audit includes two options; one to extend the existing 30mph zone to a point just east of the proposed access and another where the derestricted nature of the road remains unchanged but a splitter island is to be installed just to the west of the proposed access to ensure that eastbound vehicles approaching the proposed access, do not encroach the opposing lane and thus ensure the achievable visibility accords observed speeds. The scheme drawing illustrates that illuminated keep left bollards are to be provided which should highlight the features to approaching drivers, however, due to the existing alignment of Bird in Eye Hill to the west as well as vegetation abutting the carriageway, forward visibility for eastbound drivers is limited. As such, there may be insufficient warning of the traffic island which could lead to vehicles striking the feature and a loss of control type incidents.

It is recommended that sufficient forward visibility is achievable to an object within the carriageway

The Highway Authority are supportive of the extension to the 30mph speed limit and as set out in MfS2, the starting point for visibility on non-trunk roads is MfS. It is clear that Bird in Eye Hill is not a trunk road and sufficient forward visibility is achievable.

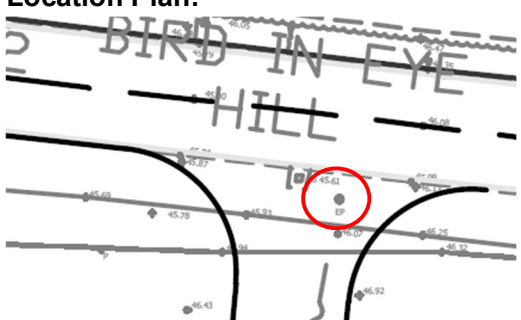
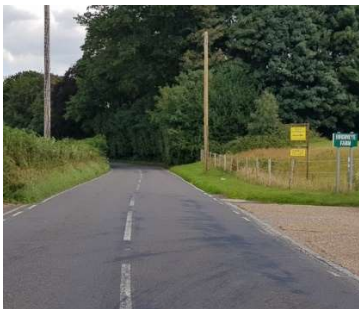
**Location:** Proposed access

**Summary:** Existing Telegraph / Electric pole will become an obstruction to vehicles

Signage and telegraph poles are situated within the existing verge along Bird in Eye Hill. The proposals relocate an existing access approximately 30 metres to the east which is to serve the existing dwellings as well as the proposed development of 300 dwellings. However, a telegraph / electric pole is situated in the proposed bell mouth access in the path of vehicles and will be an obstruction.

It is recommended that the telegraph / electric pole is relocated, and the access is free of obstructions.

| All existing street furniture, utility covers and gullies will be reviewed during the detail design of the scheme. | |

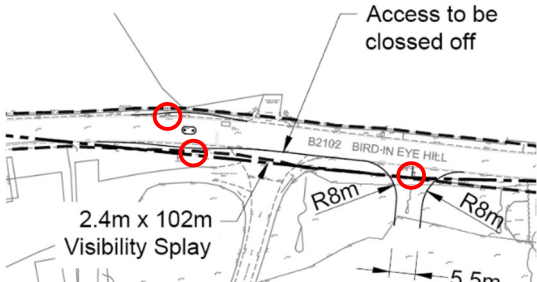
| <b>Location:</b> | Proposed Access and Bird in Eye Hill |
| <b>Summary:</b> | Existing road gully will be within the path of vehicles |
| <p>Bird in Eye Hill is cambered with surface water falling to the channels either side of the carriageway where road gullies are present. During the site visit associated with this Audit, a number of gullies in proximity to the proposed works were observed to be blocked and therefore ineffective. The proposals that introduce a traffic island to the west of the proposed access, widen the Bird in Eye Hill carriageway where a gully is present either side of the road. No details of the proposed surface water drainage have been provided at this stage; however, an insufficient network is likely to result in ponding during inclement conditions which increases the likelihood of loss of control type incidents. Furthermore, a road gully within the path of a vehicle could give rise to loss of control type incidents particularly for two wheeled vehicles and vehicles undertaking a braking manoeuvre.</p> | |

| It is recommended that an adequate surface water drainage network is provided. | |

| All existing street furniture, utility covers and gullies will be reviewed during the detail design of the scheme. | |

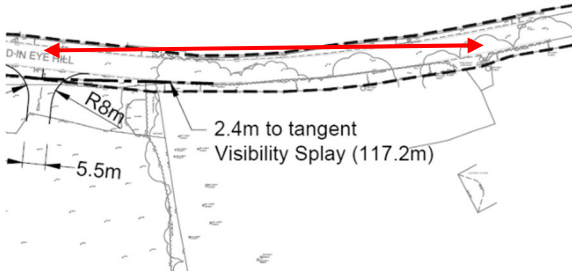
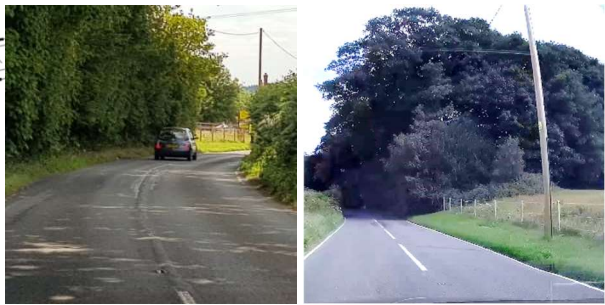
| <b>Location:</b> | Bird in Eye Hill |
| <b>Summary:</b> | Drivers approaching and waiting to turn right into the proposed access may not become aware of each other at a safe distance |
| <p>In proximity of the proposed access, Bird in Eye Hill is derestricted, subject to the 60 mph national speed limit and accommodates a bend on each approach. The proposals that are subject to this Stage 1 Road Safety Audit includes two options; one to extend the existing 30mph zone to a point just east of the proposed access and another where the derestricted nature of the road remains unchanged but a splitter island is to be installed just to the west of the proposed access to ensure that eastbound vehicles approaching the proposed access, do not encroach the opposing lane and thus ensure the achievable visibility accords with the splays illustrated. The Audit Team took measurements whilst on-site and visibility splays of 2.4x117.2 metres and 2.4x102 metres are achievable from the proposed access to an approaching vehicle, however, due to vegetation within the verge to the north of the carriageway, forward visibility to and from a vehicle attempting to turn right into the access, is restricted to below 117.2 metres for westbound drivers. As such, a westbound driver will have insufficient warning of the traffic attempting to turn right and vice versa.</p> | |

| It is recommended that the sufficient forward visibility is achievable | |
| <p>As stated by the Auditor's, the proposed access is clearly visible for westbound drivers and as such, one would approach cautiously in the knowledge that a vehicle may attempt to turn right. It must be noted that a right turning vehicle will be moving across the carriageway and not be a stationary object. The Highway Authority are supportive of the extension to the 30mph speed limit and in any event, MfS2 advises that the starting point for calculating visibility for non-trunk roads</p> | |

| should be MfS. It is evident that sufficient visibility is therefore achievable to/from the proposed access. | |

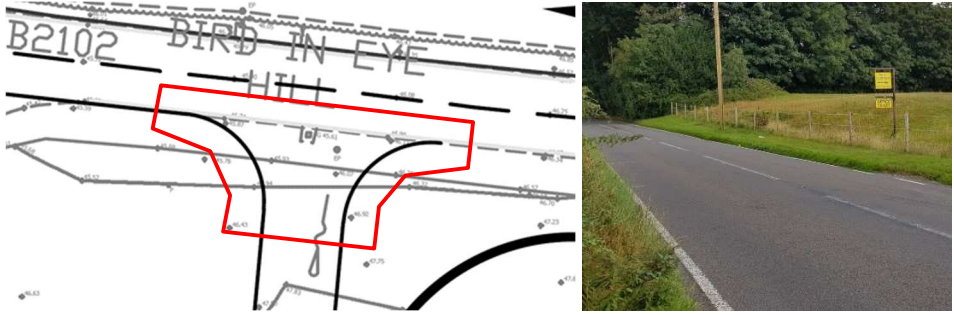
| <b>Location:</b> | Proposed access |
| <b>Summary:</b> | No road markings are provided to highlight the need for exiting vehicles to give-way |
| <p>The existing access arrangement serving a mixed-use development on land at Bird in Eye Farm does not accommodate any road markings. The proposals subject to this Stage 1 Road Safety Audit are to provide a priority access that serves a development of 300 dwellings. The scheme drawings provided with the Audit Brief provided do not identify that any carriageway markings are to be provided at its junction with Bird in Eye Hill. Vehicles exiting may not therefore align themselves sufficiently to allow space for a vehicle to enter simultaneously which could give rise to sideswipes type incidents as well as rear end shunts along Bird in Eye Hill and junction overshoot type incidents.</p> | |

| It is recommended that road markings are provided to guide vehicles sufficiently. | |
| Give-way and road centreline markings are to be provided. | |

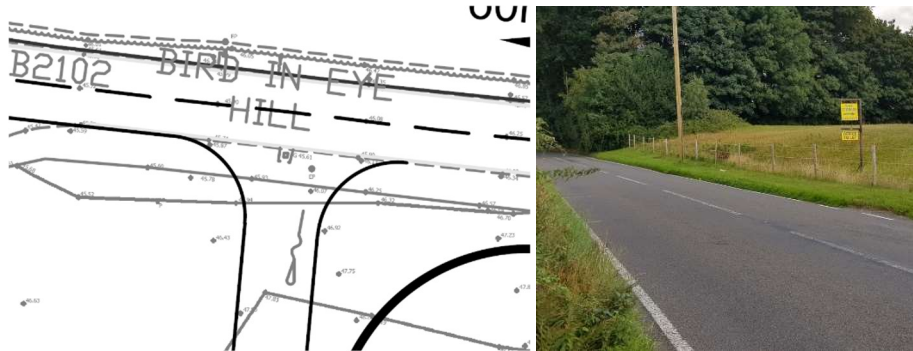
#### Location Plan:

| <b>Location:</b> | Proposed access arrangement |
| <b>Summary:</b> | Insufficient space may be provided to allow service vehicles to enter |
| <p>The existing access to Bird in Eye Farm is approximately 5 metres wide with large corner radii that allow for Heavy Goods and Agricultural Vehicles to manoeuvre safely. The proposals include the relocation of the priority access with 8 metre corner radii which provides access to a 5.5m wide carriageway. No swept path analysis has been provided with the Audit Brief and as such, the corner radii may not be sufficient to allow for the infrequent HGV movements that could be expected from a development of 300 dwellings. Should turning movements be restrictive, vehicles could be required to encroach the opposing lane or vehicles may be required to reverse out of the</p> | |

proposed access or in order to enter and exit the access raising the risk of rear-end, sideswipe collisions.

It is recommended that the proposals allow for all expected movements.

A swept path analysis has been undertaken and the proposals are adequate for the expected vehicles.

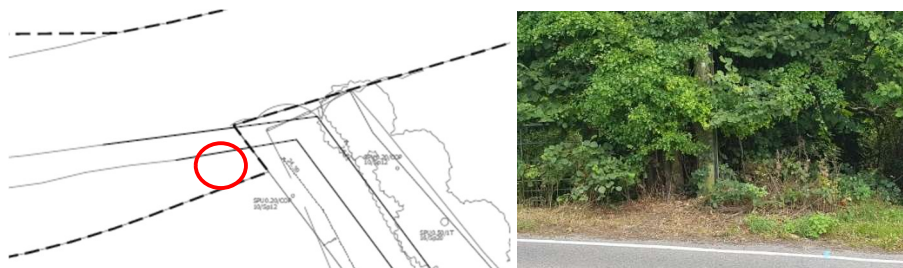
#### Location Plan:

**Location:** Proposed footpath connection, Bird in Eye Hill

**Summary:** Existing signage will become an obstruction to pedestrians

In proximity of the proposed footway cycleway access the verges of Bird in Eye Hill accommodates a number of telegraph / electric poles and road signs. The proposals introduce a connection between Bird in Eye Hill and the local pedestrian network, to the west of the proposed access via footpath through a wooded area. An existing telegraph / electric pole is situated just to the west of the proposed connection will be situated central to the footway and become an obstruction to pedestrians that could force one to enter the carriageway suddenly raising the risk of vehicle collisions with pedestrians.

It is recommended that the telegraph pole is relocated.

| All existing street furniture, utility covers and gullies will be reviewed during the detail design of the scheme. | |

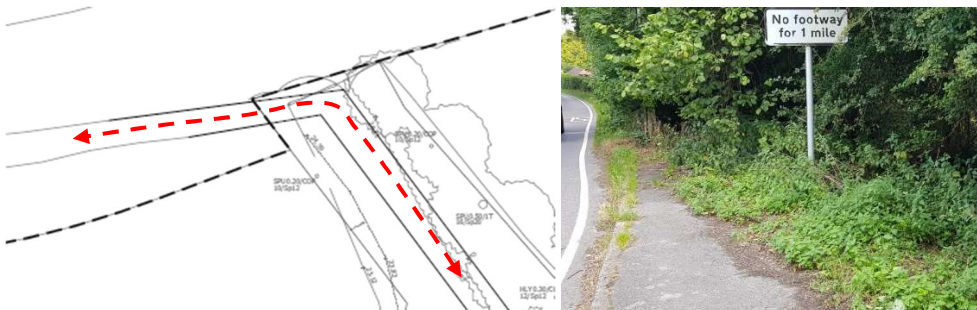
| <b>Location:</b> | Proposed footpath connection, Bird in Eye Hill |
| <b>Summary:</b> | Cyclists are likely to utilise the proposed footpath |
| <p>Bird in Eye Hill benefits from a footway along the southern side that terminates just to west of the gated access to the application site. The scheme drawing provided with the Audit Brief illustrates that a footpath connection is proposed at this location which is approximately the same width as the existing footway, however, as identified within the Transport Assessment associated with the scheme, a 3.0-metre wide shared use footway / cycleway link is to be provided. The proposed link is considerably shorter than following Bird in Eye Hill and as such, it is highly likely that cyclists will utilise the link. Should the link be insufficient to accommodate a high number of pedestrians and cyclists, there could give rise to cyclist-pedestrian collisions.</p> | |

| It is recommended that the width of the facility is increased appropriately to accommodate cyclists | |
| The section of footway between the pedestrian/cycle access and the bus stops to the west will be widened to 3m to facilitate its use as a shared footway/cycleway. | |

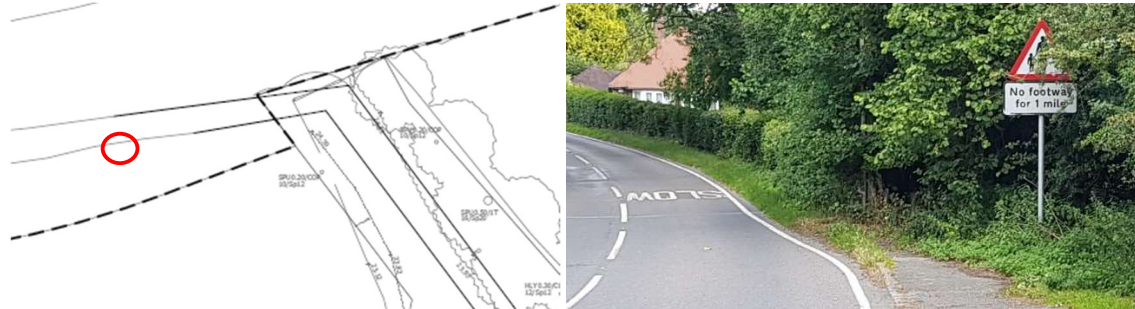
#### Location Plan:

| <b>Location:</b> | Proposed footpath connection, Bird in Eye Hill |
| <b>Summary:</b> | Existing road sign could become an obstruction to users of the footway |
| <p>Bird in Eye Hill benefits from a footway along the southern side that terminates just to west of the gated access to the application site at a location where a 'pedestrians in carriageway' road sign with a 'no footway for 1 mile' plate is present. The sign face appears to provide insufficient</p> | |

headroom for a pedestrian to walk beneath. Should a pedestrian step slightly off the existing footway, the sign would be an obstruction resulting in a personal head injury.

It is recommended that the sign face is relocated further back from the edge of footway or raised to a suitable level

All existing street furniture, utility covers and gullies will be reviewed during the detail design of the scheme.
