**BIRD-IN-EYE FARM, UCKFIELD,  
TN22 5HA  
LAND CONTAMINATION  
ASSESSMENT –  
PHASE 1 DESK STUDY REPORT  
*CROUDACE HOMES AND  
MR & MRS BERRY*  
26/05/2020**

| <b>Title:</b> | <b>LAND CONTAMINATION ASSESSMENT –<br/>PHASE 1 DESK STUDY REPORT</b> |
| <b>Project:</b> | <b>NEW RESIDENTIAL DEVELOPMENT</b> |
| <b>Reference:</b> | <b>LS 5030</b> |

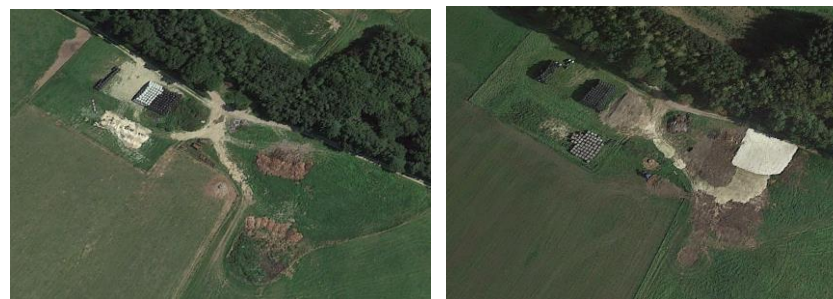
An area (known as a muck pile) was noted in the south east of the site. The maximum extent appears to have been in 2014 (see below). Not much detail was discernible from the imagery, but hay bales, soil, vegetation and some vehicles were noted.

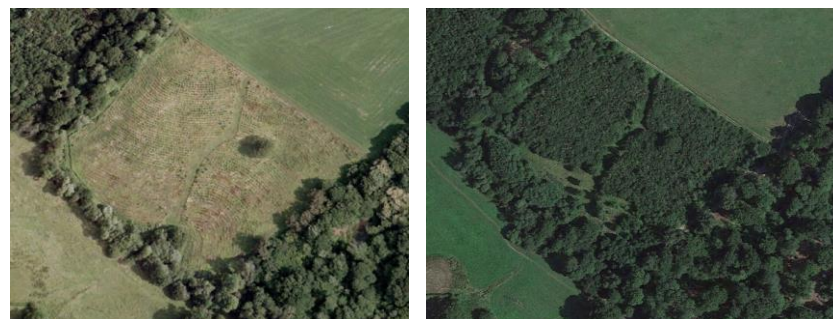
The southern part of the site appeared to have been planted with saplings some time prior to 2004 and by the latest imagery the areas appears to have become further established.

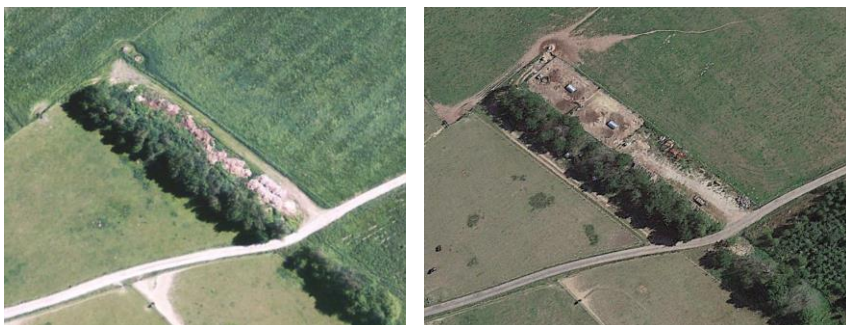
A similar storage area was noted in the north-east of the site, which appeared to have been used over time for the storage of materials and possibly keeping of livestock.

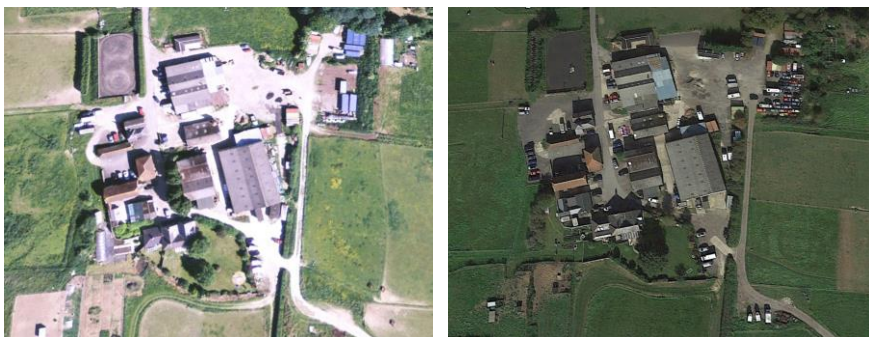
The main farm area appears relatively unchanged on the aerial photography. The parking area to the west of the premises appears to have been extended slightly. The area of storage in the north-west of the farm appears to have become increasingly more used during the period.

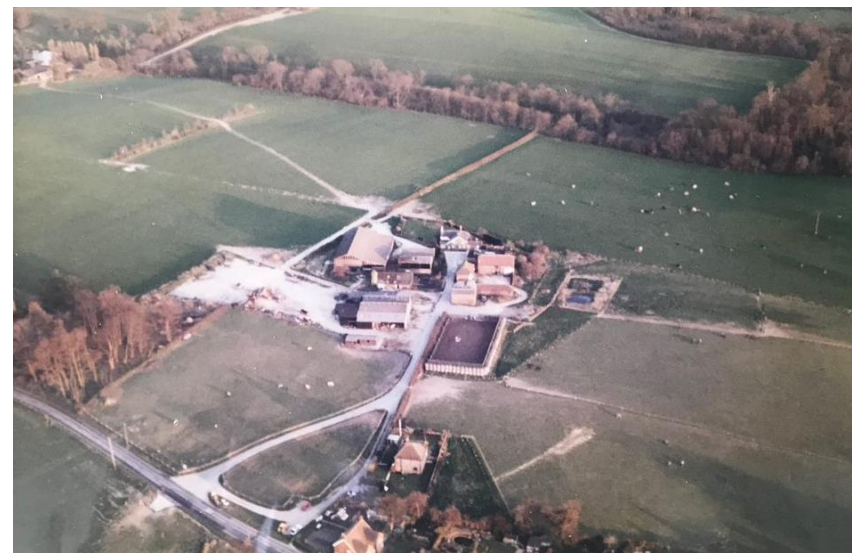
A privately held aerial photograph of the farm (understood to be taken around the year 2000) was shown to Land Science, which revealed 2no slurry pit to the west of the main farm (to the right of the buildings, with the photographs being taken towards the south).

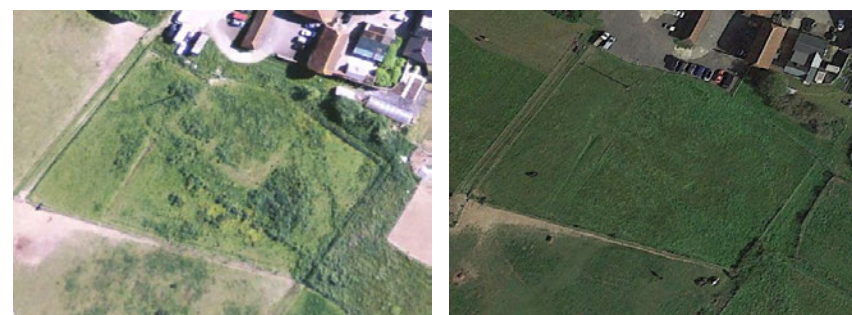
The Google imagery shows the area to be hummocky slightly overgrown ground which appears to have been levelled over time.
