# Draft Conservation Area Character Appraisal

## Maresfield

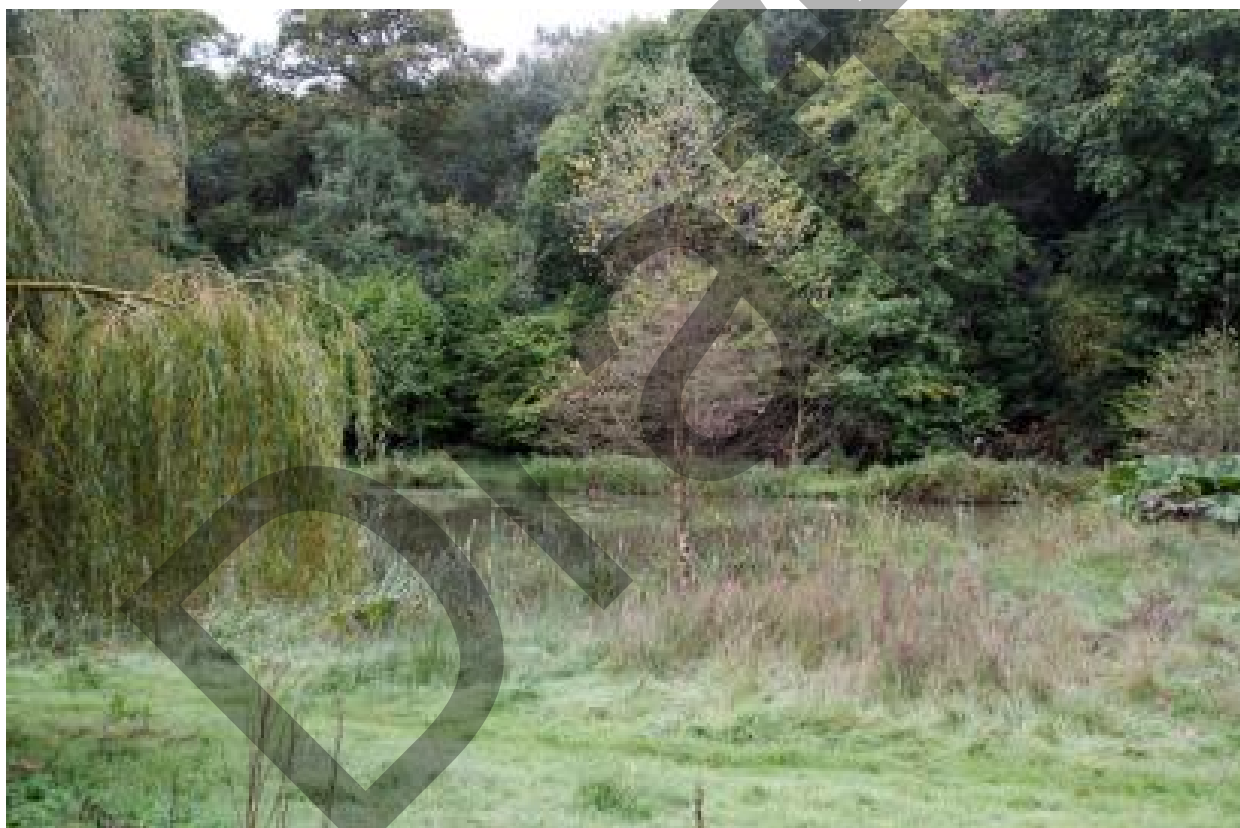
#### Former hammer pond in Underhill

charcoal-burning. There is evidence for possible hammer ponds in the landscape through the Underhill area and it is likely that Underhill Lake is an enlarged pond that may well have served the Maresfield (Powdermill) furnace to the west. It is understood that the first cannon was cast in East Sussex in 1543, at a furnace in Buxted, a few miles to the southeast of Maresfield, by Ralph Hogge. By 1574, there were at least 77 iron furnaces working in the Weald, with five known iron furnace sites in Maresfield Parish: Oldlands, Old Forge, Maresfield (Powdermills), Hendall and Lower Marshalls; but the ironmaking industry within the Weald had largely died out by the end of the 18th century.

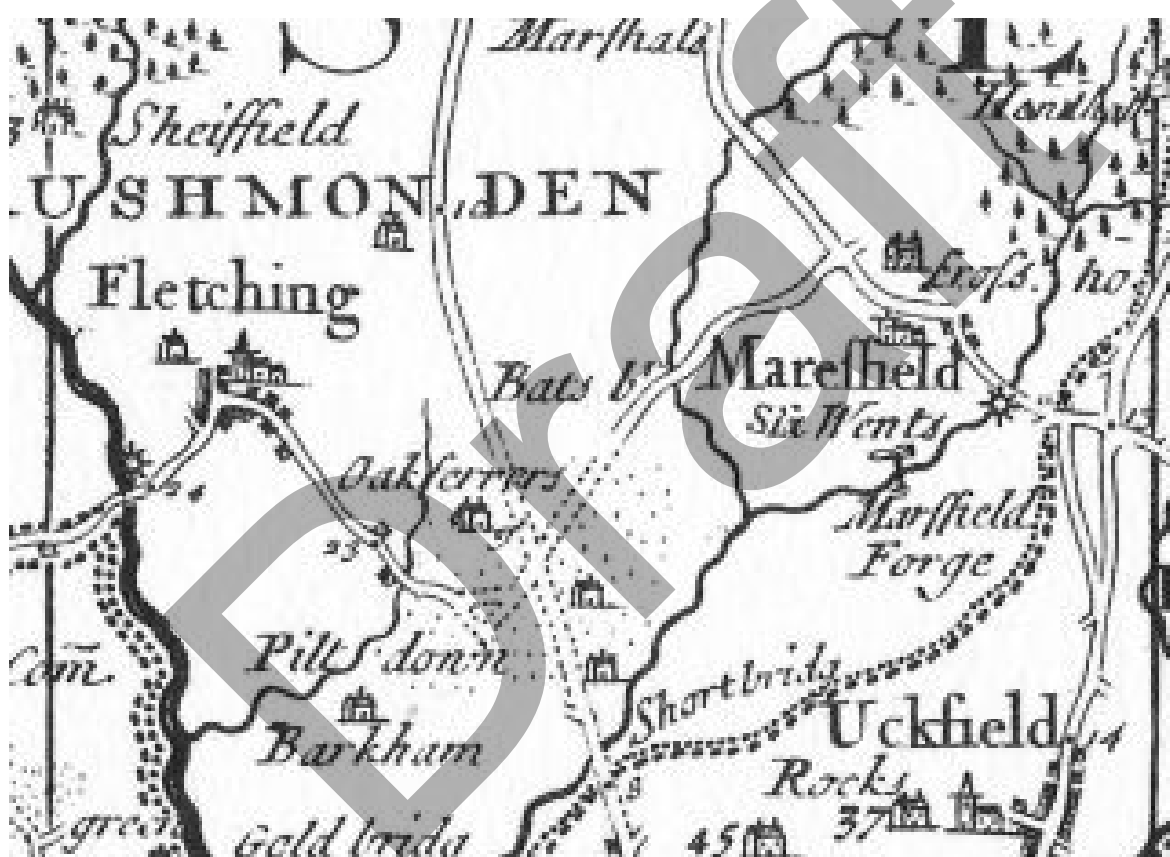
Map, c1724, Richard Budgen

**2.6.2** The earlier maps are representative of settlement and tend to lack detail, although some of the early Estate maps do show individual buildings and features with some accuracy. The area is also covered by the maps produced by the Budgen family of cartographers, who lived in the District. The maps produced by different generations of the family include those of Sussex produced by Richard Budgen in 1723-4. The 1 inch to 1 mile map of Sussex produced in 1724 by Richard Budgen shows the village of Maresfield depicted as the church and small cluster of houses and mill and forge to the south on the stream.

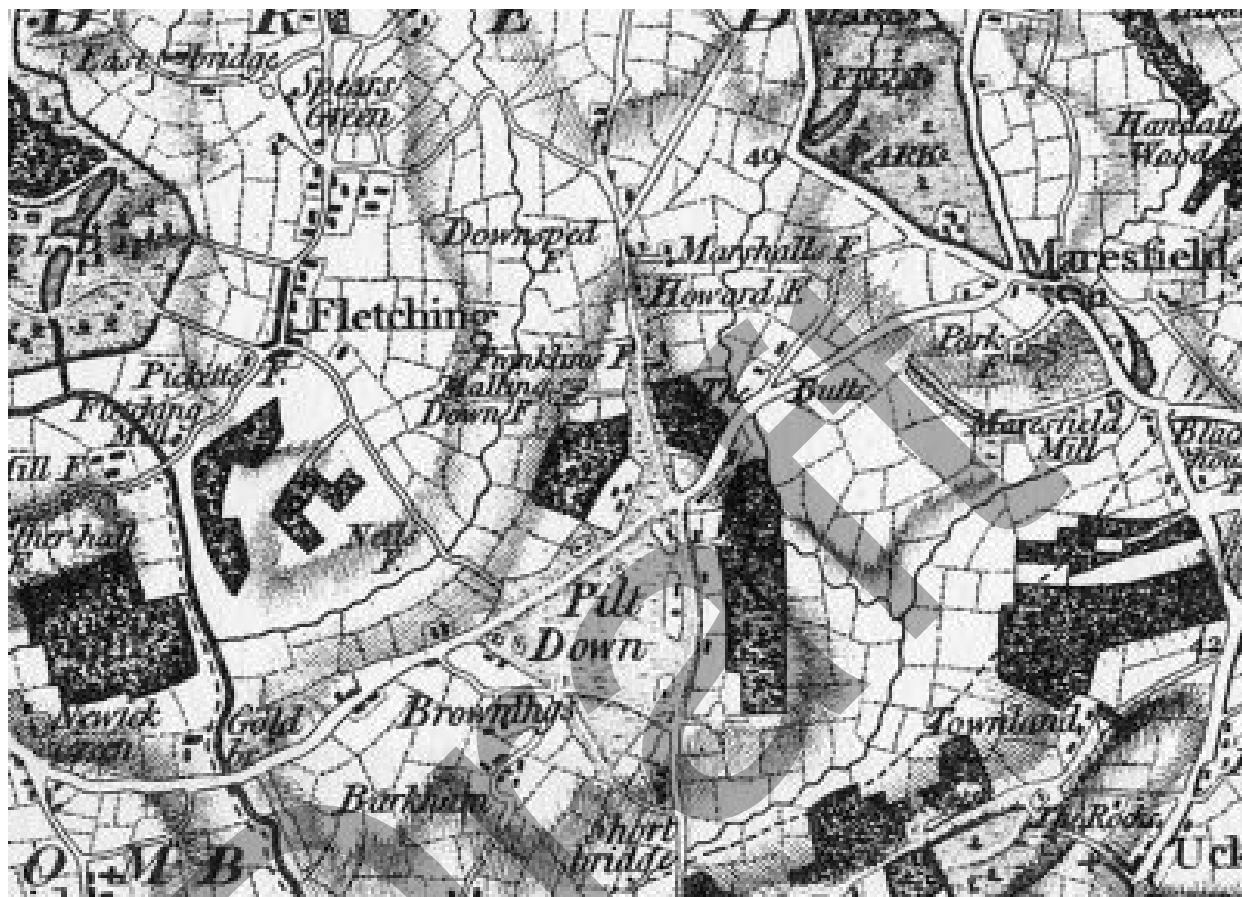
Map, c1795, Gardner and Gream

**2.6.3** By 1795, the 1 inch to 1 mile map of Sussex produced by William Gardner, Chief Surveying Draftsman to the Board of Ordnance and Thomas Gream, Surveyor to the Board of Ordnance, shows that Maresfield has grown in size, with additional built form depicted around the central crossroads and east into Underhill. Maresfield Park is shown as an enclosed area between the two parallel roads running north and Park Farm is also annotated. The map still shows Maresfield Mill, but all reference to the forge has now been removed.

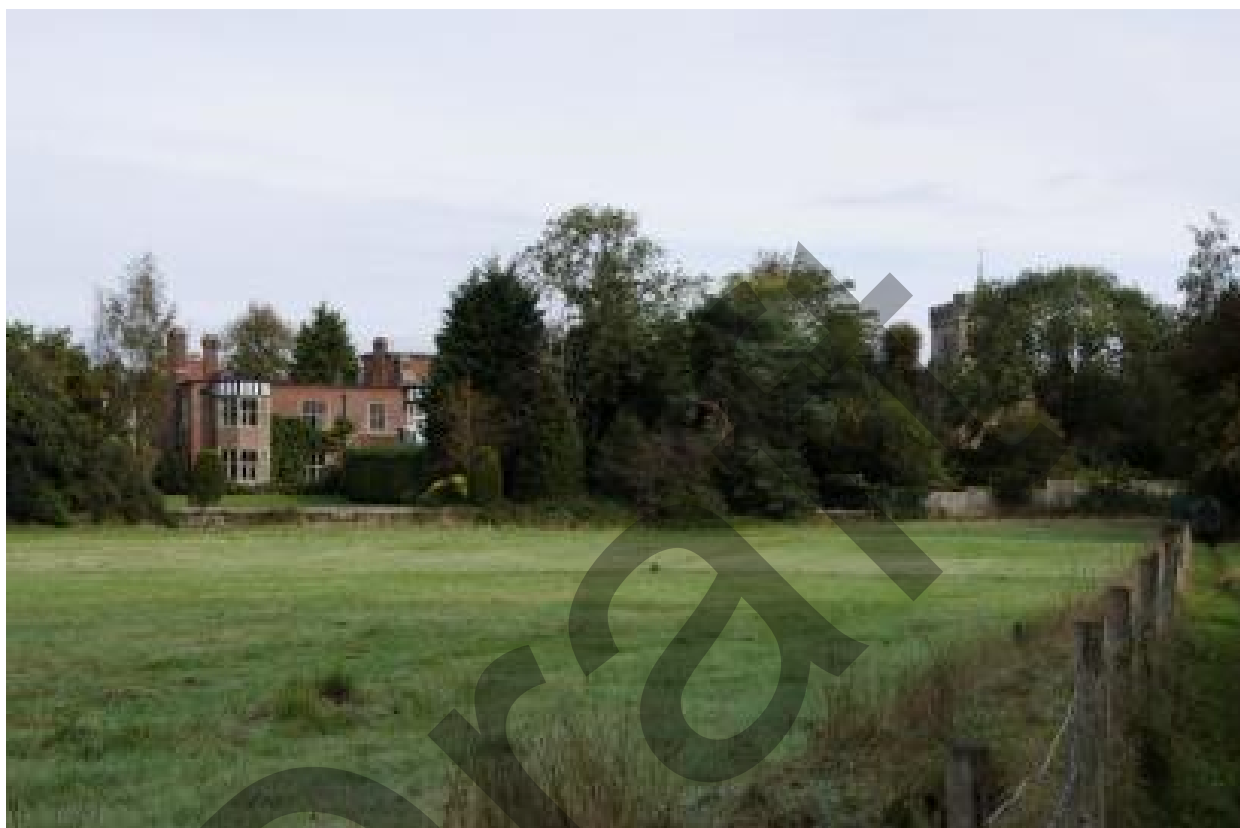
**View across open space towards the former Rectory (Park Field and Brent House) showing ha-ha wall and glimpse of church**

**3.3.8** There are two open spaces within this character area comprising the churchyard to St. Bartholomew's and the open field to the west of Park Farm Lane. The churchyard is important in itself as the historic graveyard associated with the church. However, it is also important as the immediate historic setting of the church for archaeological purposes due to evidence for an earlier religious structure on site, and also forms part of the footpath network to the wider countryside to the south. The open field to the west of Park Farm Lane, south of the church is particularly important to the setting of the historic core of the village, and affords views through to the church tower. It also has a visually important relationship with the former Rectory, now Brent House and Park Field. The southern boundary of these properties is formed by a stone ha-ha wall, allowing uninterrupted views out of the grounds, but preventing grazing animals from trespassing. This type of boundary is an unusual feature and would indicate some form of historic relationship between the former rectory and this open field area, forming an intentional relationship between the two. Due to the type of boundary, there are important views across this open space, from the public footpath and also from Park Farm Lane, towards the former Rectory. It is also important that very little modern development has actually occurred to the south of the historic core, thereby retaining a more traditional setting of the village within the wider landscape and preventing coalescence with Park Farm, which has historically been separate to the village. The rural location of the farmstead has already been eroded by development to the west, and the retention of this important open space to the south of the former Rectory helps to maintain the historic separation and character.

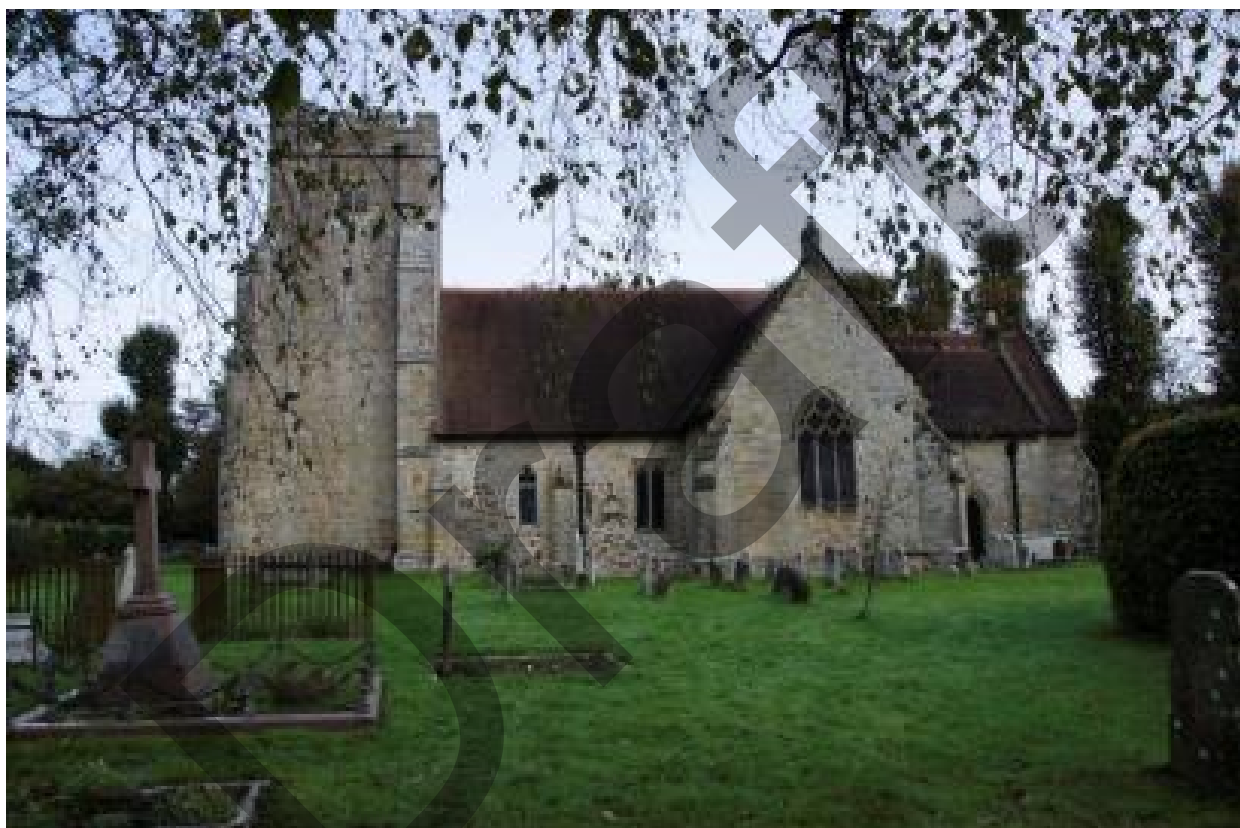
#### St Bartholomew's Church - south elevation

are generally in the perpendicular style, with stone tracery to the larger examples. The north porch to the nave is the main entrance into the church, and has a Horsham stone slate roof and decorative Gothic style pierced barge boards to the gable. Particularly interesting detailing includes decorative iron box profile guttering; and the decorative iron door furniture to the external timber door to the north transept. Sir John Villiers Shelley of Maresfield Park is buried in the churchyard.

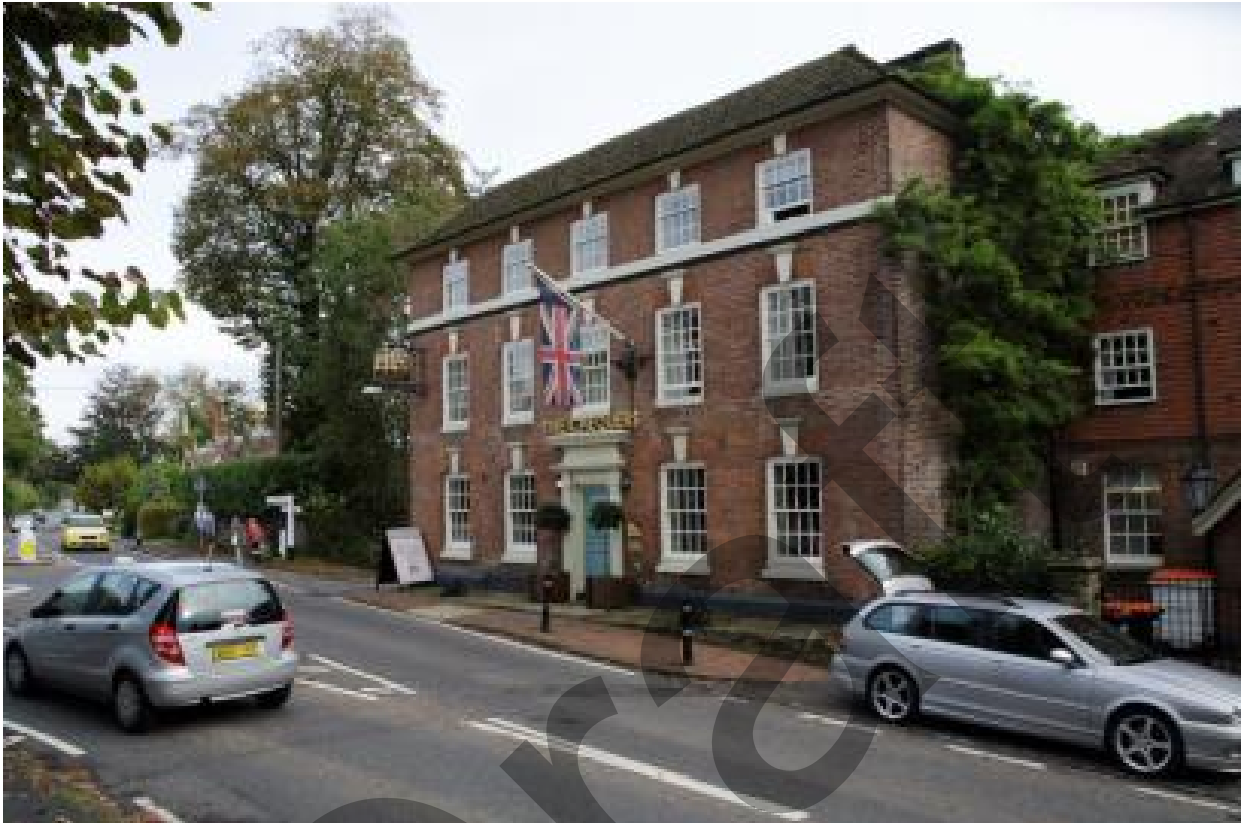
### The Chequers Inn

**3.3.17** The Chequers Inn dates from the 18th century and is a substantial three storey Georgian brick building with hipped tiled roof, located in a prominent location on the eastern side of the main road junction in the village centre. The building was originally a coaching inn on the route between London and the coast. The symmetrical front elevation is characterised by the ground and first floors with original sixteen pane vertical timber sliding sash windows with prominent keystones rubbed brick arches. The entrance door is central with an elaborate door surround comprising Doric pilasters and double cornice, with sash window above to the first floor. The second floor is typically less important in the visual hierarchy of the front elevation, with smaller four over eight vertical timber sliding sash windows above a painted string course. A later extension to the south of the original building is appropriately recessed so as to allow the form and character of the original Georgian building to be fully appreciated. To the rear of the main building, several of the original outbuildings to this coaching inn survive and are important to the historical context of the use and to the development of the core of the village as a whole. The buildings have been sensitively converted to modern uses in conjunction with the main building.

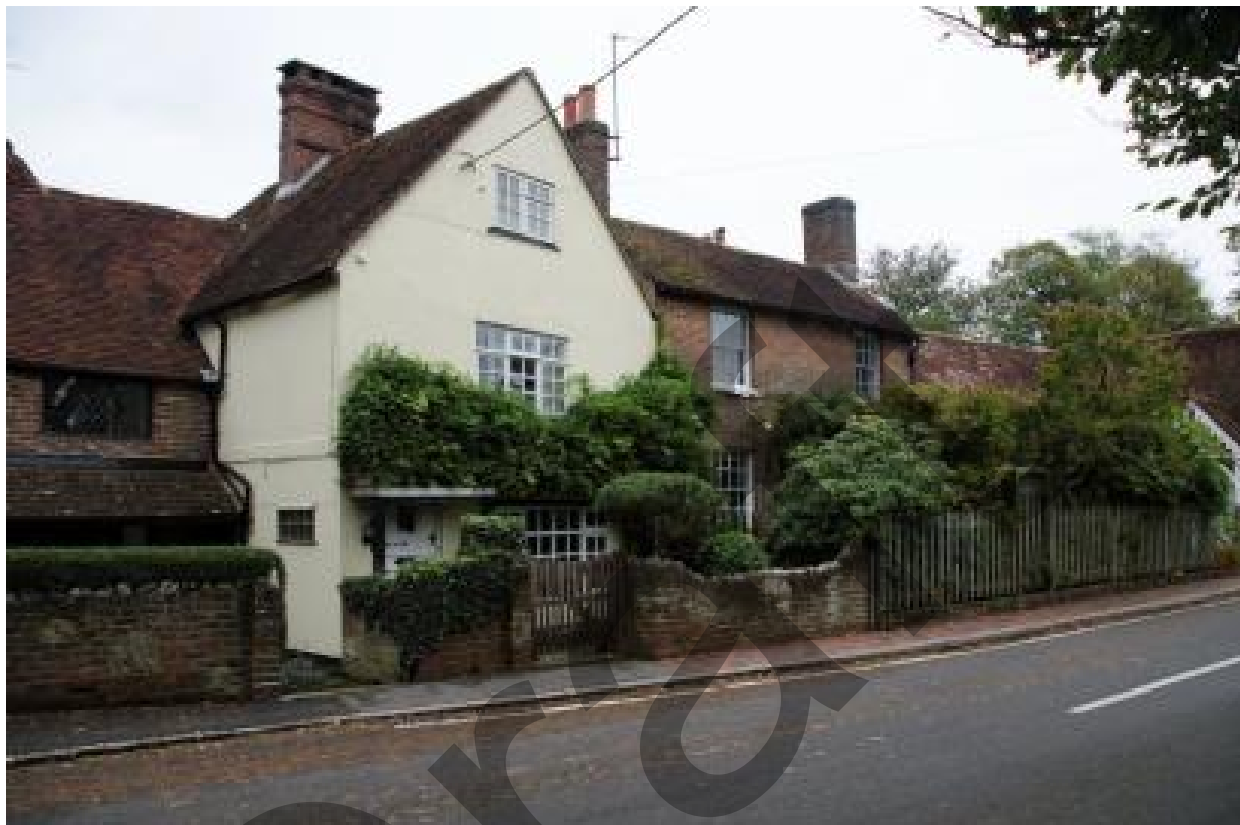
### Bix Cottage, Tumber House and Newnham Cottage

**3.3.18** Bix Cottage, Tumber House and Tudor Cottage are a range of buildings, once forming a single house, fronting on to the northern side of Batts Bridge Road at what would have been the original western entrance into the village. The buildings have been surveyed relatively recently and the earliest parts within Bix Cottage date from the late 14th century. The range of buildings has been altered over the intervening period in the 16th and 18th centuries, and latterly in the 19th and 20th centuries, but the earliest parts would have comprised a 14th century hall house with service bay to the west, a two bay central open hall and parlour bay to the east. A limited amount of the original timber framing is still evident internally, and a brick facade was added to the medieval buildings in the 18th century. The windows and doors were subsequently altered in the 19th and early 20th centuries. Although there has been substantial changes made to what was a 14th century hall house, the core of the building is a remarkable survival and demonstrates the evolution of earlier properties throughout the centuries.

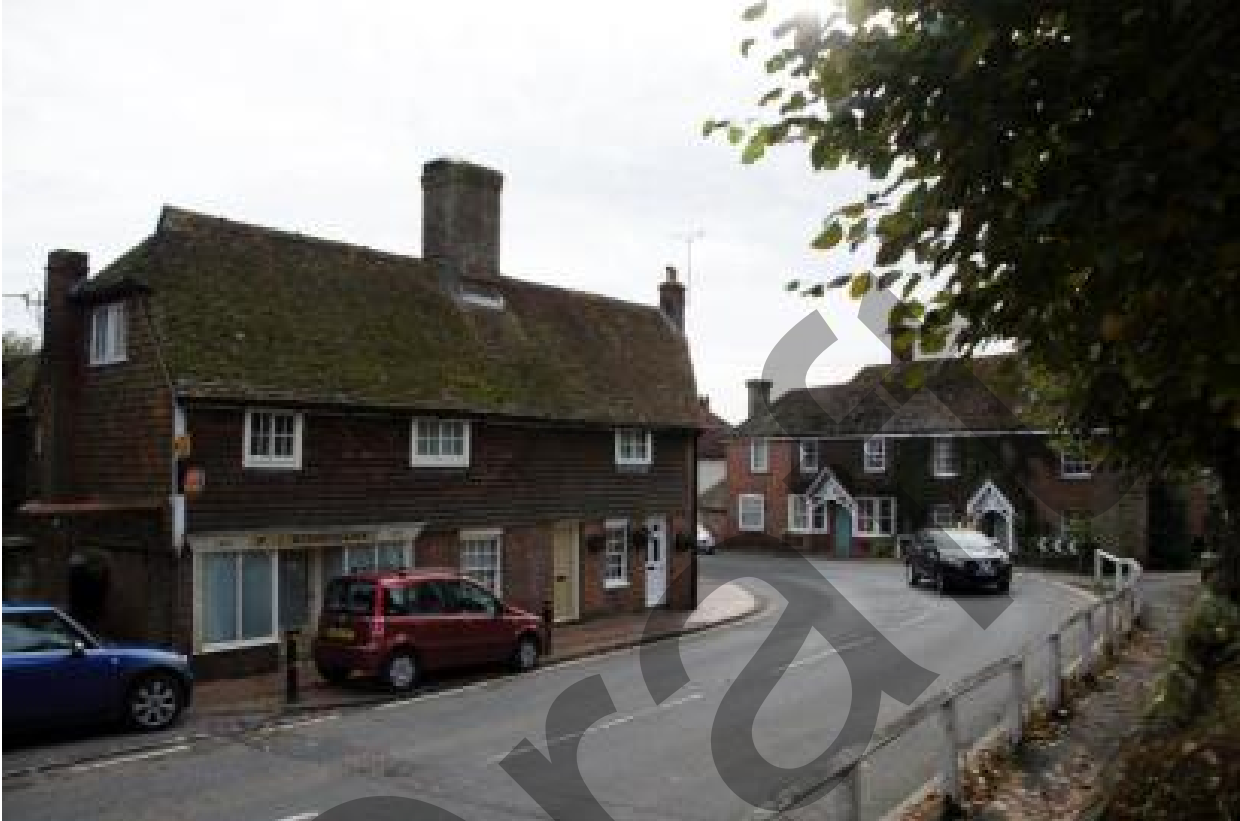
## Village centre

**3.3.19** There is a significant group of buildings dating from the 16th century in the High Street to the east of the church. This group includes Number 23, 30, 31, 32, and 33. All of these buildings are timber-framed, but have been refaced in brick, painted in some instances, and with some tile hanging to first floor areas. Within this group of buildings are examples of traditional detailing, including horizontal sliding sash windows, a 19th century shop front, and porches with decorative barge boards.

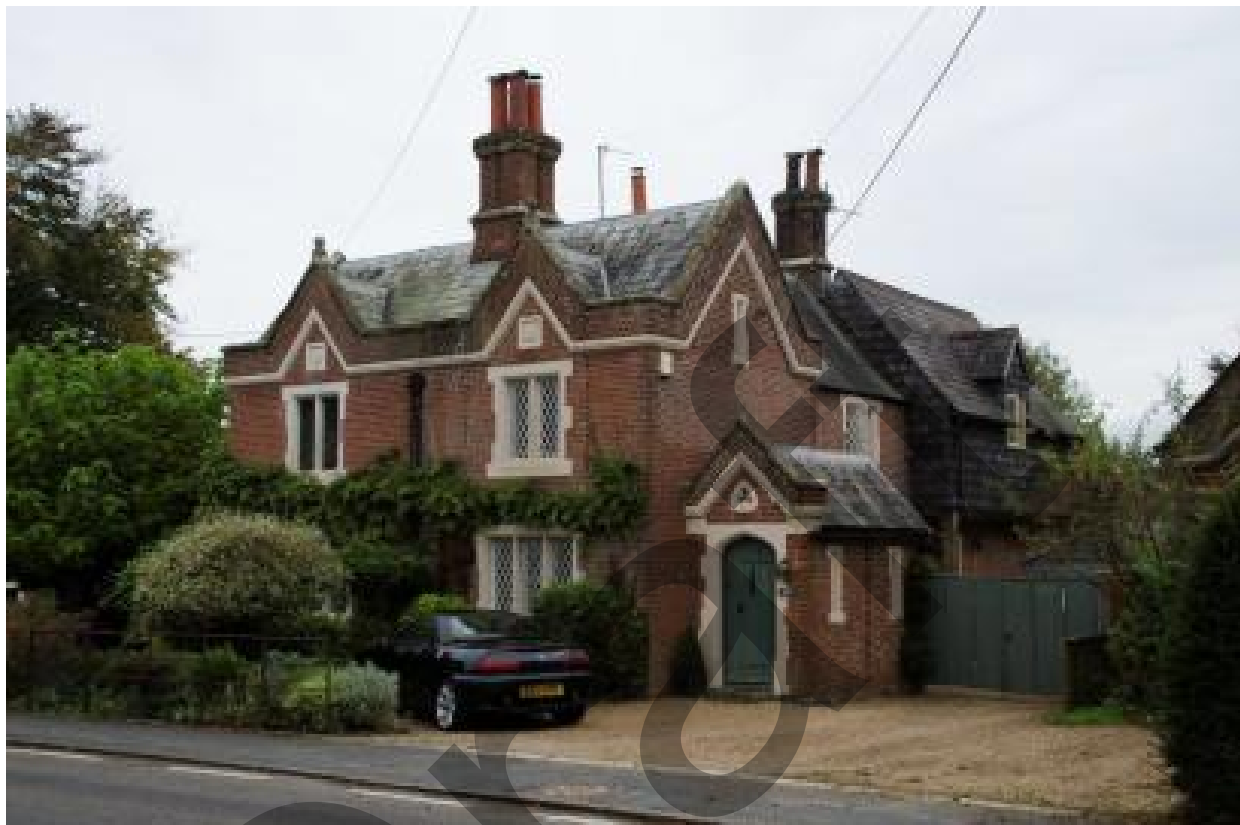
## Shelley Villas

**3.3.21** Shelley Villas are two pairs of red brick, slate roofed, 19th century cottages in Tudor Gothic style. The original detailing of each pair has remained remarkably intact and they help to form the northern entrance into the historic core of the village. These buildings are particularly significant for their relationship to the history of the village and connection with the Shelleys of Maresfield Park. The facade to each pair has parapets with two small gables with stone capping and ball finials. The brickwork in the gables runs parallel with the angle of the roof and sits above a projecting moulded stone string course. The windows are diamond paned cast iron casements with stone mullions and surrounds. The entrance porch for each property is located at the side and mirrors the parapet and gable detailing to the front facade, with the doors within a stone surround. A large central brick chimney stack with four pots serves each pair, with a subsidiary two stack chimney to the rear of each dwelling. Within the front gable for each property is a plaque with the date 1846 under an insignia comprising the letters JSV for John Villiers Shelley, and above the front doors, in the small gable, is a stone trefoil detail.

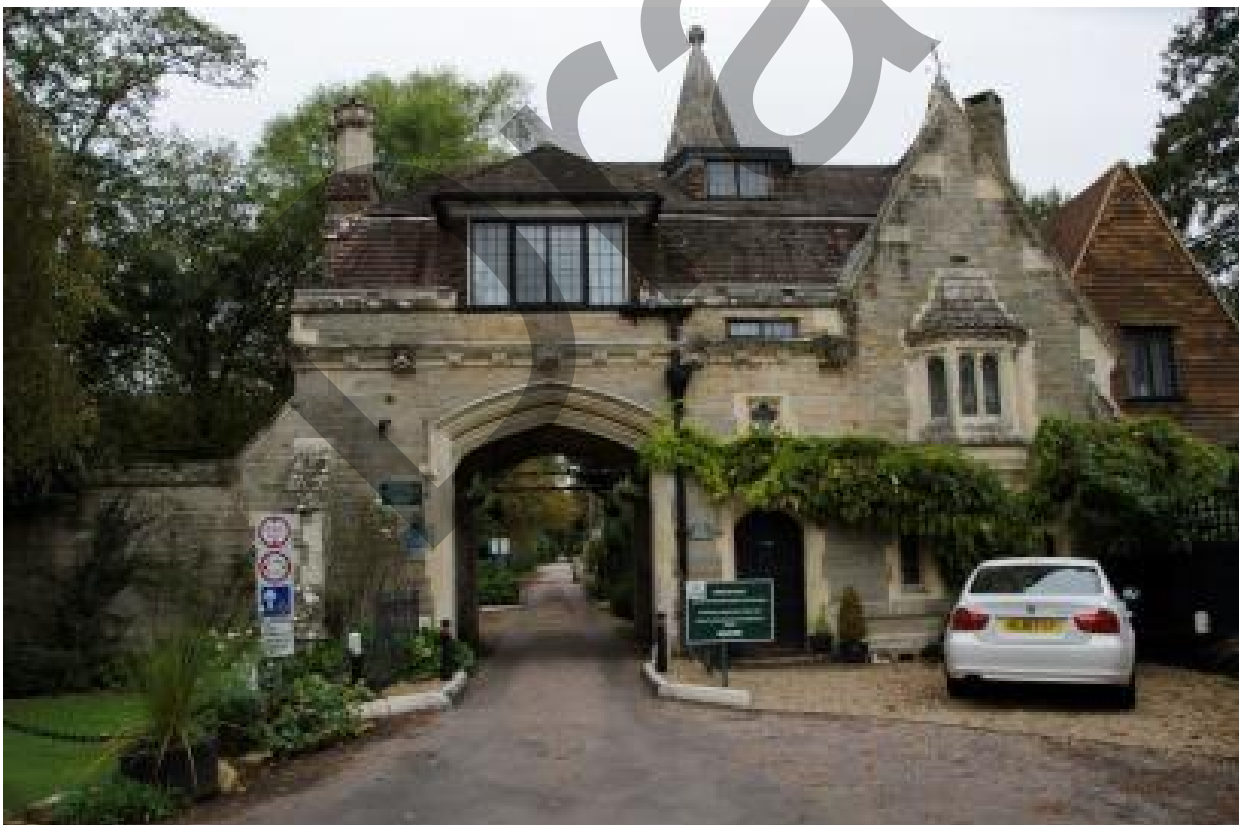
**Maresfield Park Lodge**

**3.3.25** The Gothic style stone Lodge House to the northern side of the central road junction was built as the entrance lodge, with gateways and gates to Maresfield Park around 1847 by Sir John Villiers Shelley. Although the building has been extended and altered, predominantly in the mid and late 20th century, it still retains an impressive presence within the centre of the village. The original southeast facade of the building is constructed of stone and retains much of its original detailing including a large four-centred carriage arch to the left, with a former pedestrian entrance under an arch, now incorporated within the residence, with a quatrefoil-shaped window above. To the extreme right of the original front facade is a steep gable with a first floor oriel window flanked by lancet windows on the ground floor. This building has been locally listed due to its social, cultural and historic interest to Maresfield village.

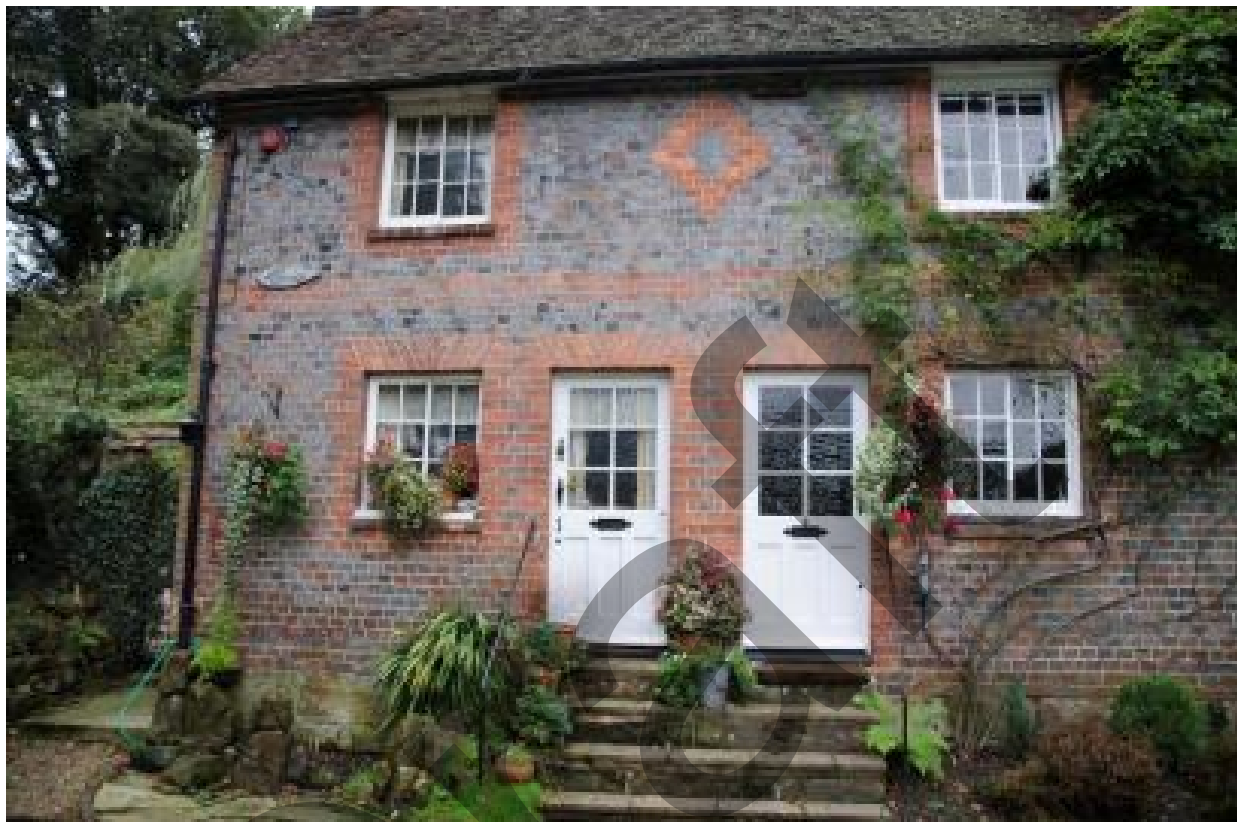
### 1 & 2 Underhill Cottages

**3.4.18** Underhill Cottages, located directly below Mount Pleasant, at the base of the hill, front on to Underhill Lane. They are an exceptional example of either late 18th century or very early 19th century workers cottages, in a terrace of four dwellings, which have remained unaltered. The terrace has two pairs of entrance doors to either end to serve the four dwellings. The front elevation comprises header bond in a decorative brickwork pattern, using burnt headers, with detailing picked out in red headers, including a string course at first floor and a diamond shape above the front doors to each pair of cottages. The casement windows are horizontal sliding sashes of six panes each, and the front doors are six panes over three recessed panels, with matching door furniture. These unlisted buildings enhance the conservation area, represent good local and vernacular detailing and represent the cultural history of the area.

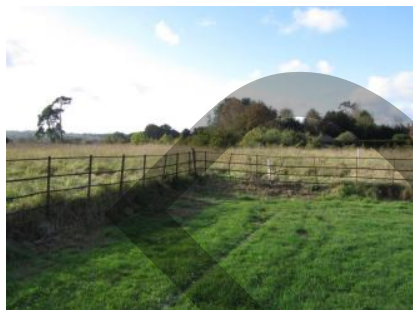
**Estate fencing to  
boundary of recreation  
ground**

**3.5.5** The land forming the recreation ground was gifted to the village by the Count Munster of Hanover, the owner of Maresfield Park, for this specific use in 1897, in commemoration of the diamond jubilee of Queen Victoria. Four stone markers were erected at each corner of the recreation ground, and these still exist. There is also a decorative iron lamp at the entrance to the ground from the High Street. To commemorate the occasion, the Empress Frederick of Germany, Queen Victoria's eldest daughter, came to Maresfield to plant an oak tree in the vicinity of the recreation ground. The southern boundary of the recreation ground is marked by a continuous traditional metal estate fence, possibly dating from the time the land was gifted to the village, returning a short distance to the north along the western boundary. Elements of estate fencing survives within hedgerow on the west boundary and in the northwest corner of the ground.

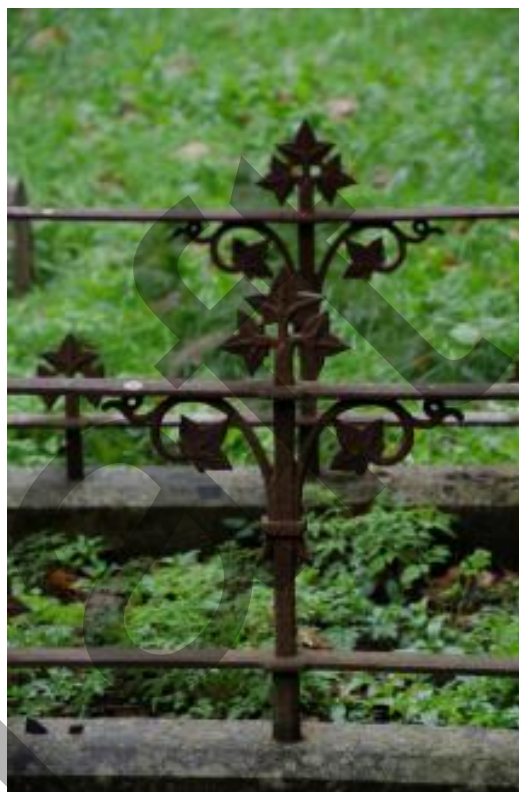
**Grave iron railings detail**

graveyard, there is a remarkable survival of decorative ironwork that has been used to demarcate graves, along with traditional stone tombs or grave markers.

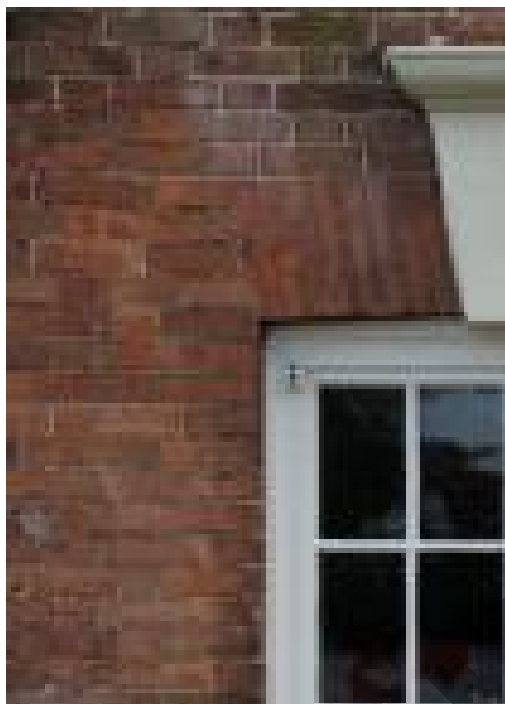
**Flemish bond and rubbed brick arch to window head**

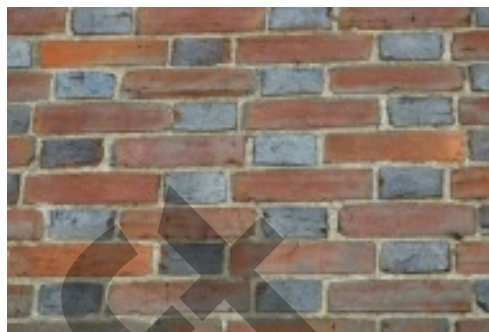
**Flemish bond - use of dark glazed headers**

**Flemish Bond:** The use of bricks laid in an alternating header and stretcher pattern to create a chequerboard pattern. The headers are often a heavier fired, darker brick, which are vitrified (glazed). **Galleting:** Slivers of stone or splinters of flint, spalls or small pebbles inserted into the mortar joints of a rubble or flint wall to fill the gaps between stones and leave less mortar exposed.

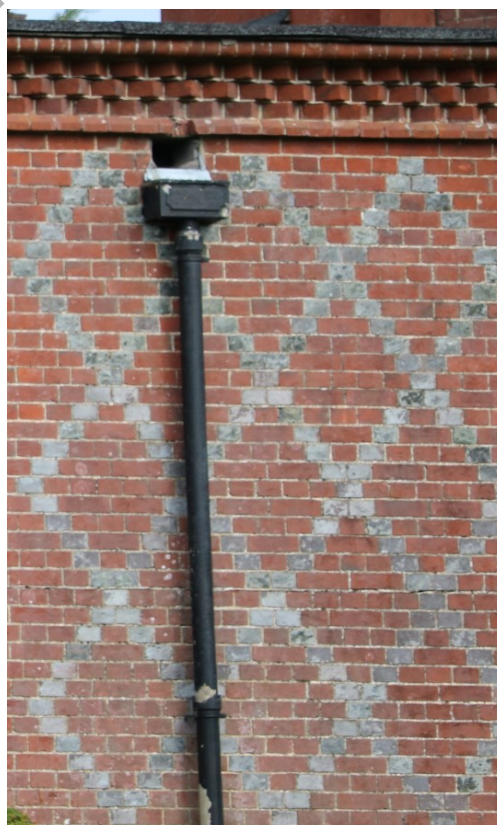
**Diaper brickwork**

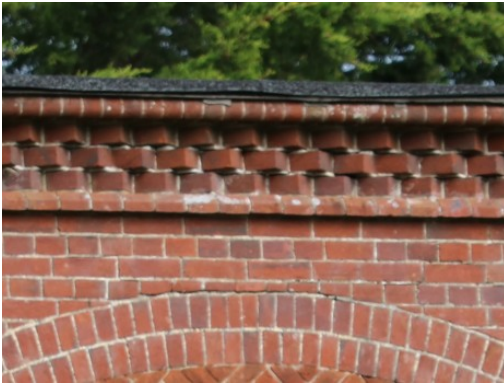
**Brick dentilation course**

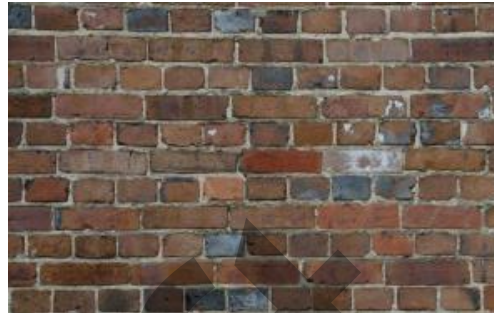
**English Bond**

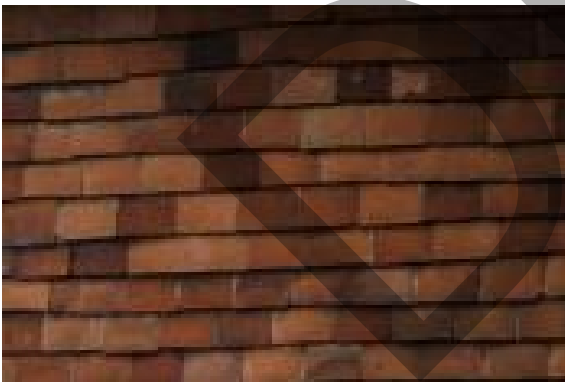
**Tile hanging**

**4.4.8** In conjunction with the 18th century refacing of earlier timber-framed buildings with brickwork, there is significant use of tile hanging to first floor areas. Similar to bricks, tiles would have been readily available locally due to the geology of the area. The tile hanging in the conservation area is plain, without any use of decorative tiles.

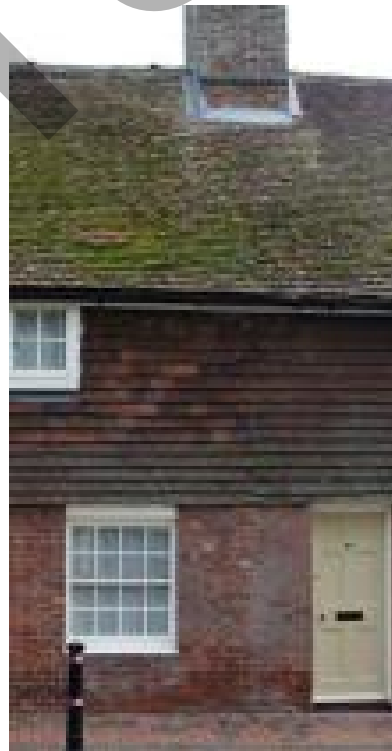
**Plain tile hanging at first floor level**

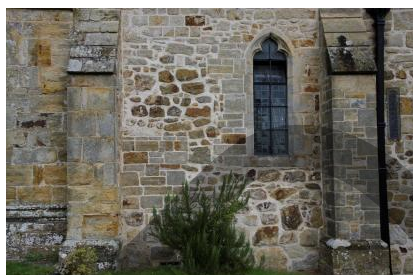
**Church - stone detailing**

**4.4.10** Where stonework has been used for construction, it has predominantly been cut into blocks, and laid in courses. This 'ashlar' stonework demonstrates the higher status of buildings such as the Church and the Lodge House to Maresfield Park. The use of ashlar stone on the oast house at Park Farm was obviously a demonstration of wealth. Decorative stonework elements have also been used on the church, including hood mouldings to doorways, and tracery within lancet windows. Of particular note, is the decorative stonework on the 19th century Lodge House. This includes a string course with carved stylised animal heads, interspersed with flowers and leaves; decorative hood mouldings to the arch and doorway; and eight small animal heads to the octagonal stone chimney.

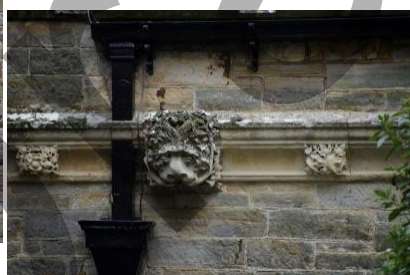
**Maresfield Park Lodge - stonework detail**

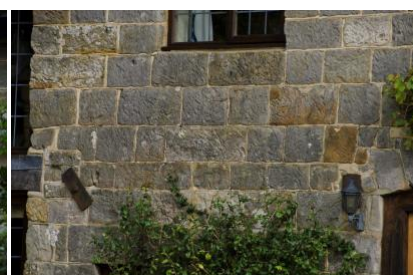
**Park Farm Oast - coursed stone**

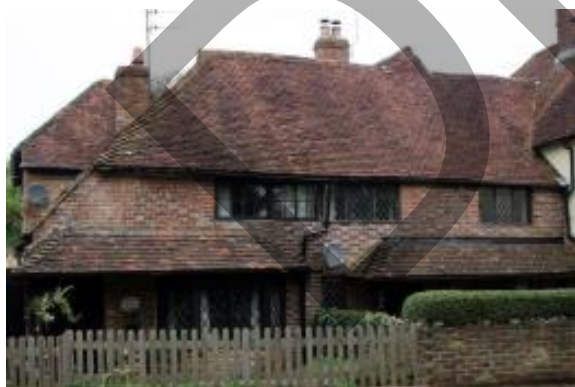
**Traditional local clay roofing tile**

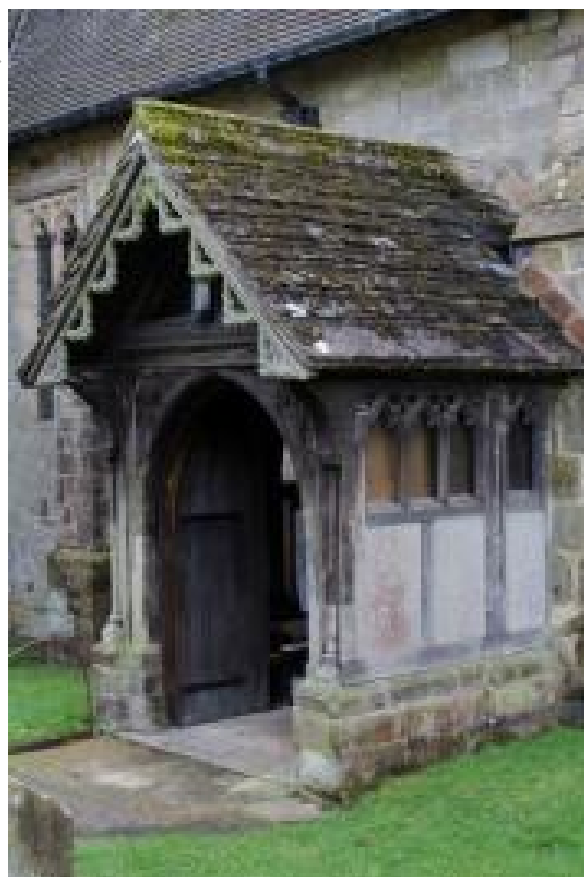
**Horsham stone slate on church porch**

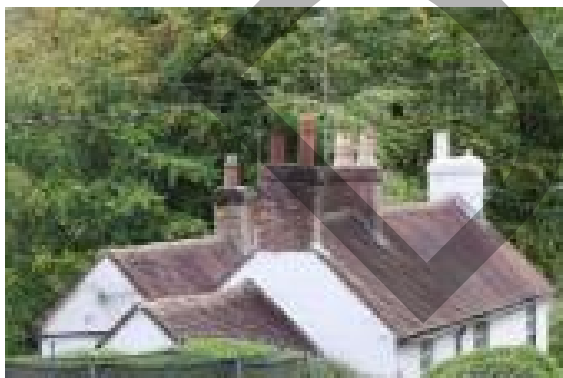
**Chimneys and pots on gabled roof**

**4.5.6** Chimney stacks and associated pots create articulation and interest to the buildings within the streetscene and are often part of the evolution and/or historic significance of a building. Loss of such features, where historic, can detract from the character and appearance of the conservation area, through an erosion of traditional detailing of buildings, and should be discouraged.

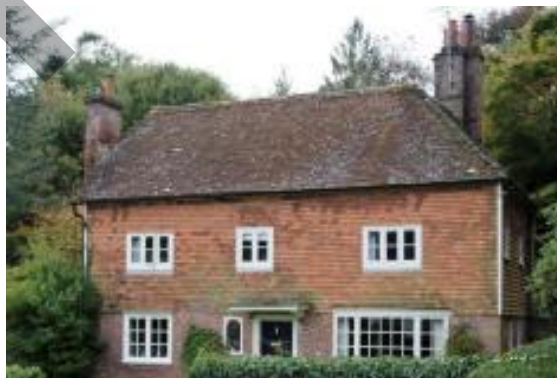
**Chimneys and pots on a hipped roof**

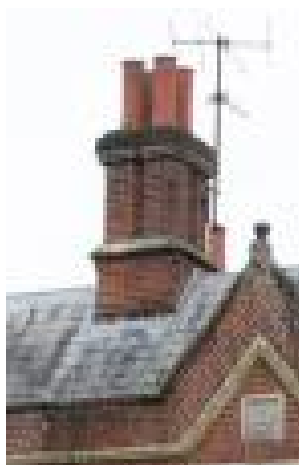
**Decorative brick chimney stack with clay pots**

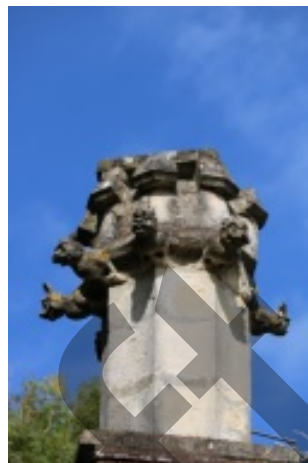
**Decorative stone chimney stack**

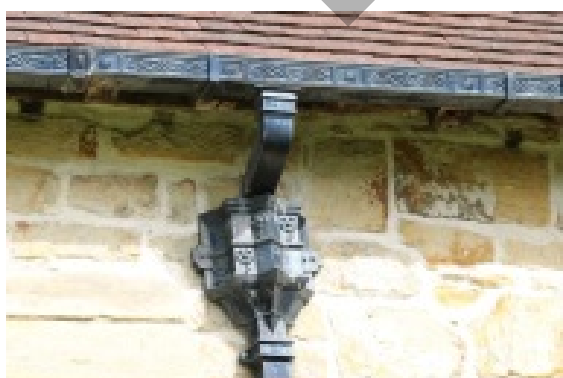
**Decorative gutting and hopper head on church**

**4.5.7** There are some fine examples of traditional rainwater goods throughout the conservation area. The church has an unusual box profile cast iron gutter with decorative leaf and flower detailing, and square box profile down pipes. The Lodge House has moulded cast iron guttering and square profile down pipes which are fitted through the decorative stone string course. At Shelley Villas, the central downpipe between each pair of dwellings is fitted into a bespoke recess within the brickwork. There are other surviving examples of the less unusual half round cast iron gutters and round cast iron downpipes throughout the conservation area, but there is beginning to be a noticeable erosion of this important detail with the use of modern, less robust PVCu guttering and downpipes.

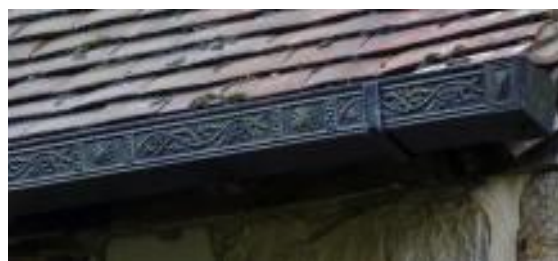
**Decorative guttering on church**

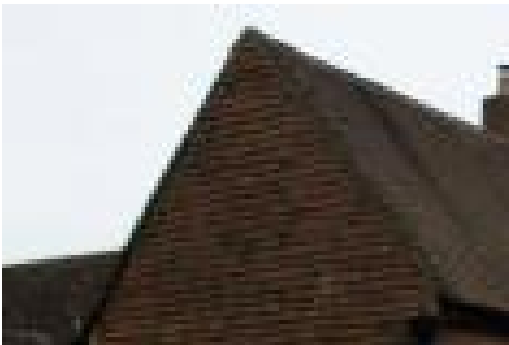
**Plain mortared verge without barge boards**

**4.5.8** There is very little use of barge boards to roofs throughout the conservation area, with the majority of gabled roofs having small mortared verges. At Park Farm, there is

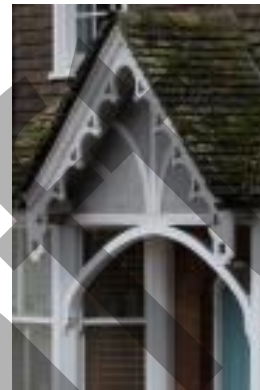
**Decorative barge board**

use of barge boards to the half hipped roof on the Farmhouse, but this is a lone example. However, there is use of decorative barge boards on porches throughout the area, with particularly good examples on the north porch of the church, to the village hall, and to Nos 24-26 High Street.

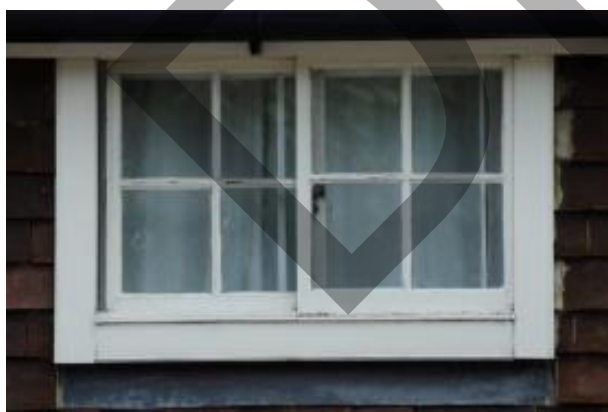
Yorkshire sliding sash - closed

**4.6.4** Where the first floor of earlier buildings has been tile hung, the main style of windows within this upper element is either side hung single glazed timber casements or Yorkshire sashes. These small window types fit within concealed timber framing behind the tile hanging on these earlier properties, such as at Forge Cottage. The use of the simpler casement style windows is often replicated at ground floor within the refaced brick facade. The larger vertical sliding sash windows have sometimes been inserted at ground floor within the brick refacing. This mix of styles is particularly evident at numbers 30-32 High Street.

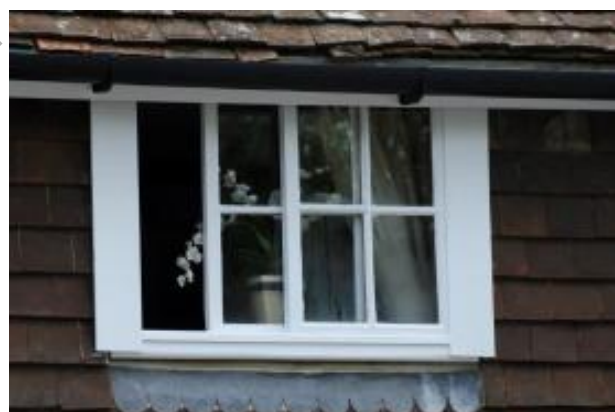
Yorkshire sliding sash - open

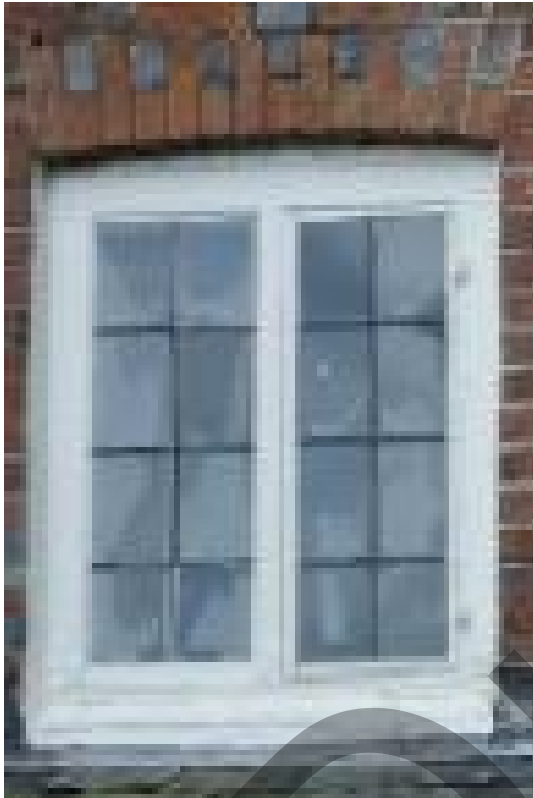
**Window - pegged frame with side hung casements with square quarries of glass within lead comes**

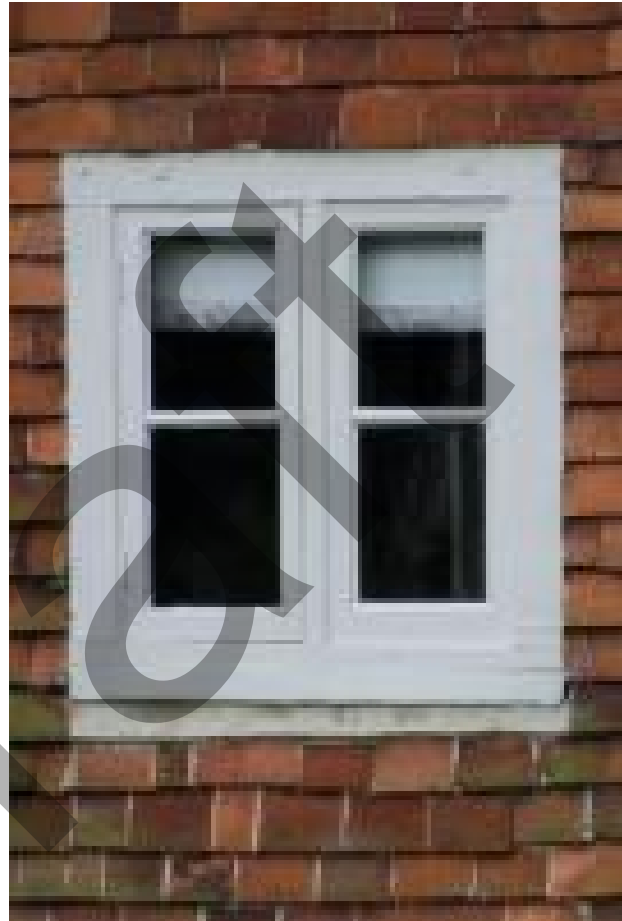
**Window - pegged frame with simple side hung casement window within concealed timber frame**

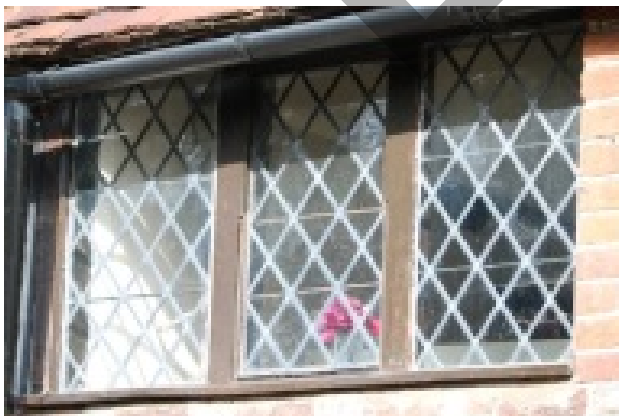
**Leaded lights in timber casement**

**4.6.5** Later lower status 18th century buildings also utilise simple casements or Yorkshire sashes, and Underhill Cottages are a particularly good example. In addition, the side and rear elevations often display more of a mixture of window styles and often even if the front elevation has vertical timber sliding sashes, the side and rear elevation will contain casement windows. These small window types fit within concealed timber framing behind the tile hanging on these earlier properties, the rear elevations of the higher status buildings can often demonstrate the use of more simply designed windows, such as the use of the timber casement window with square leaded lights at the Chequers Inn.
