# Draft Conservation Area Character Appraisal

## Maresfield

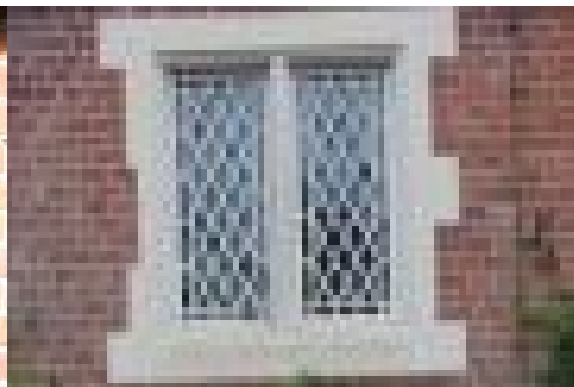
**Decorative metal window**

**4.6.6** A particularly decorative window detailing is found at the Shelley Villas properties. The windows in these 19th century dwellings are of cast metal, which is diamond paned, with rectangular pane borders. It is interesting to note that the windows have

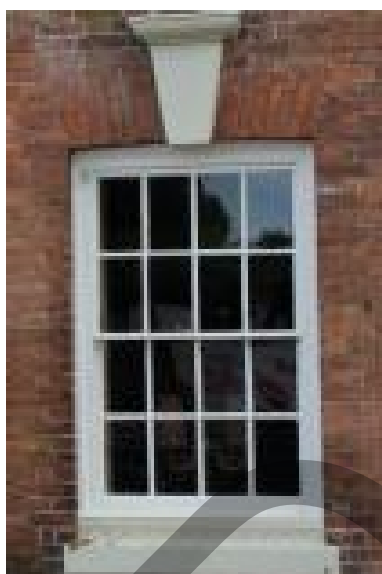
**Eight over eight vertical sliding sash window**

**4.6.7** Within the 18th century or higher status buildings within the village, small paned timber vertical sliding sash windows are the prevalent style, as evidenced by the Chequers Inn (eight panes over eight), and the former public house at Wisteria and Hillside Cottage (six panes over six).

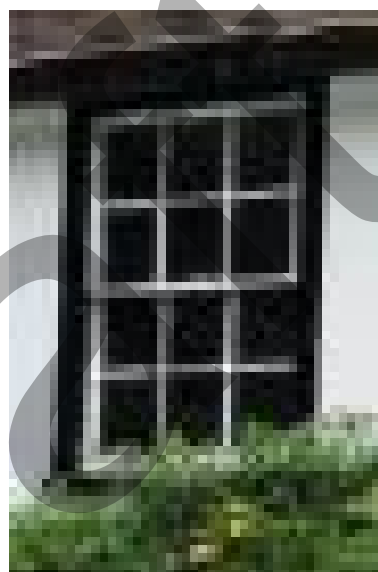
**Six over six vertical sliding sash window**

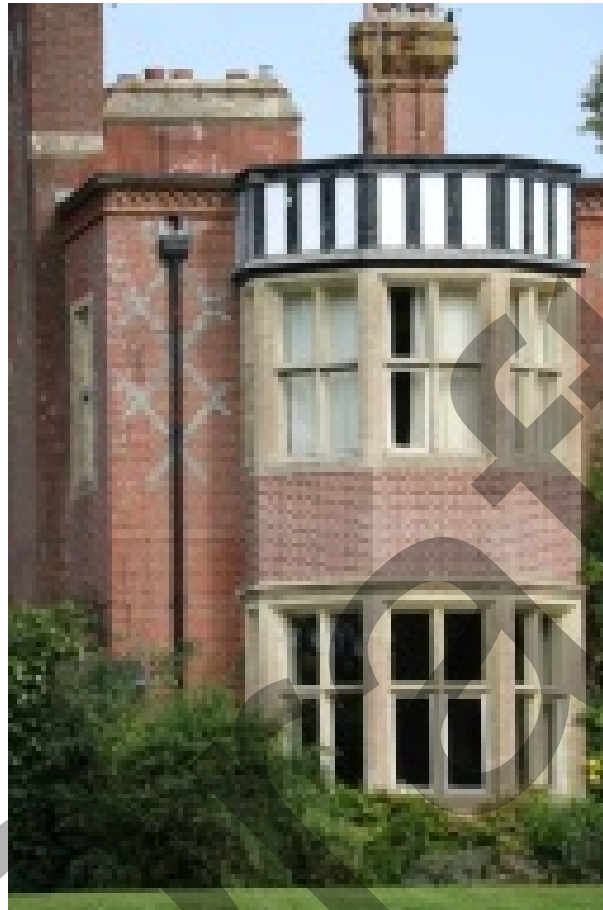
### Stone mullioned windows

**4.6.9** The use of stone mullion windows within the conservation area, is not common. The most obvious use of stonework for windows is at the church, and the examples range from early English style, to the later perpendicular style with decorative stone tracery. However stone mullion windows have also been used on individually designed residential properties, such as at the former Rectory (Parkfield and Brent House) and the Lodge House. At Parkfield and Brent House, large paned stone mullion windows are the prevalent window style. The Lodge House has a first floor stone oriel window and a small stone trefoil window.

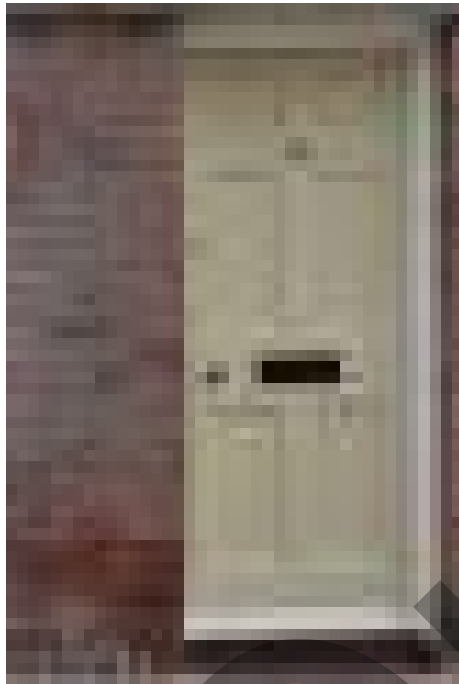
Six panel door

**4.7.2** The majority of the doors to domestic properties in the conservation area are either traditionally detailed plain planked or six panel timber doors. However, of particular note is the 18th century door case and door to the front facade of the Chequers Inn, which has Doric pilasters to either side and a double cornice above. In addition, the 19th century

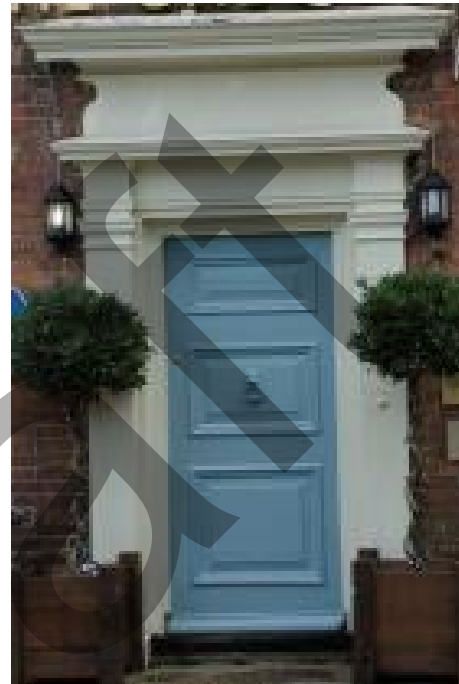
Chequers Inn - doorcase and door

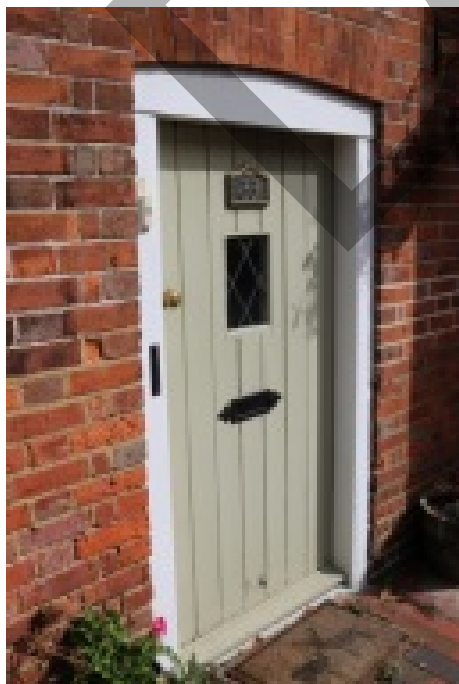
Planked door

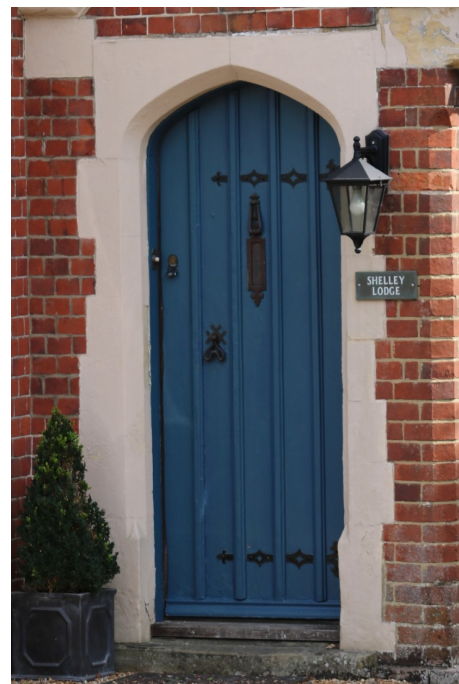
Shelley Villas - door

Shelley Villas all retain identical vertical planked arch headed doors, with beading to the planks and decorative metal strap hinges. Each door retains a vertical cast metal letterbox with integral door knocker, and decorative door handles.

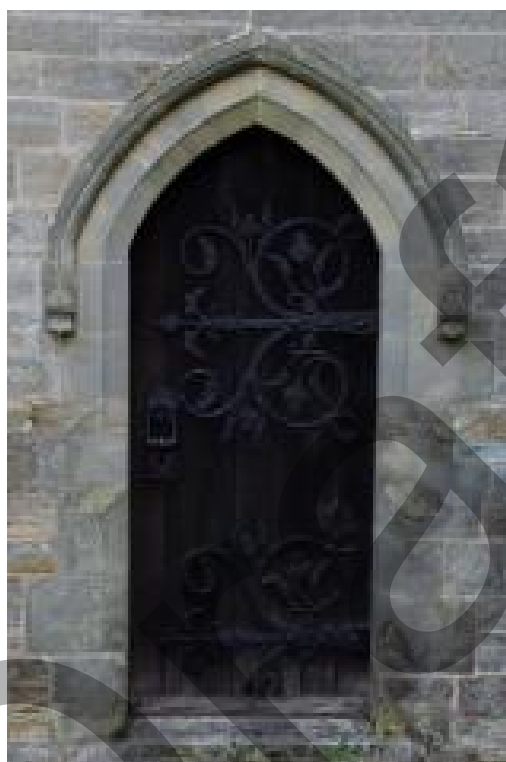
**Church door**

**4.7.3** Also of note is the door to the west elevation of the northern transept of St Bartholomews. This door has particularly decorative iron hinges with flower and leaf motifs.

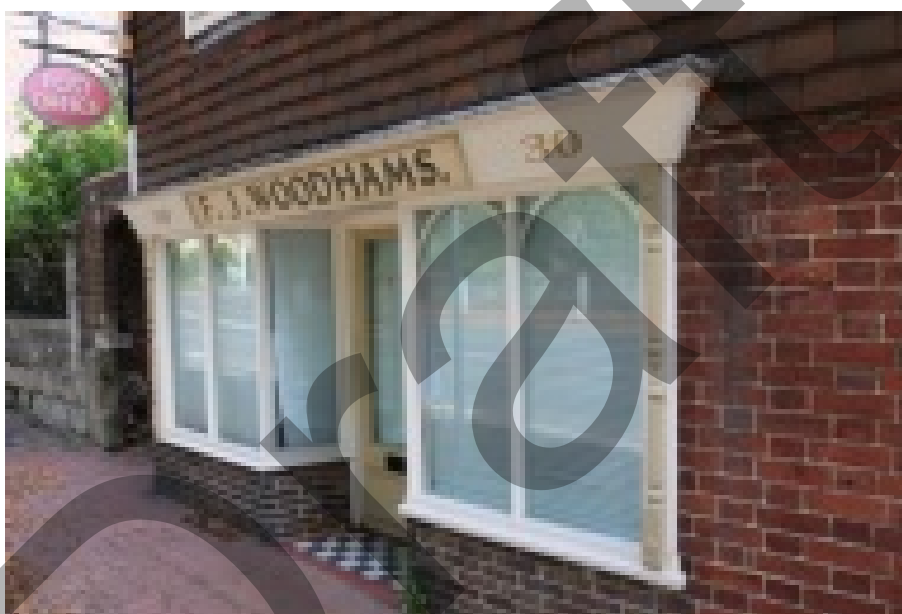
**Historic shop front**

**4.8.3** There is one remaining example of a 19th century shop window within the village at number 30 High Street. It has a recessed central door, two pane decorative arch headed shop windows to either side, with a simple brick plinth, all under a plain sign written fascia. This is an important and significant survival within Maresfield and is prominent in the street scene.

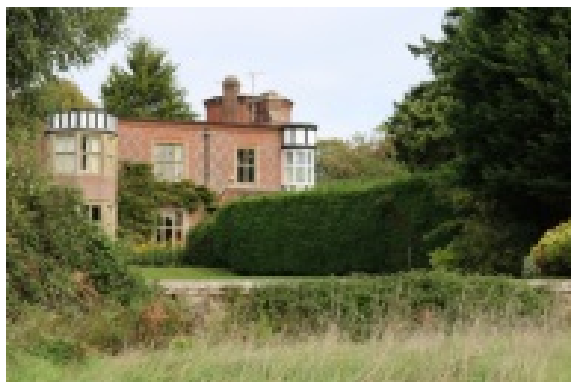
**4.9.5** A very unusual boundary treatment forms the southern boundary of the former Rectory, now Parkfield and Brent House. This boundary is formed by a stone ha-ha wall, which provided an invisible separation between the garden to the former Rectory and the

**Ha-ha wall to the garden of Parkfield and Brent House**

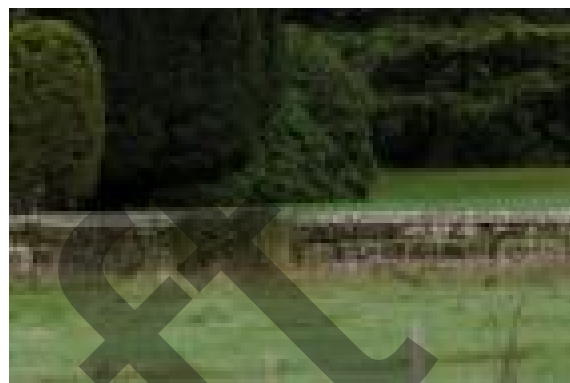
**Ha-ha wall**

field beyond, but created a physical barrier to farm animals to prevent access to the garden area.

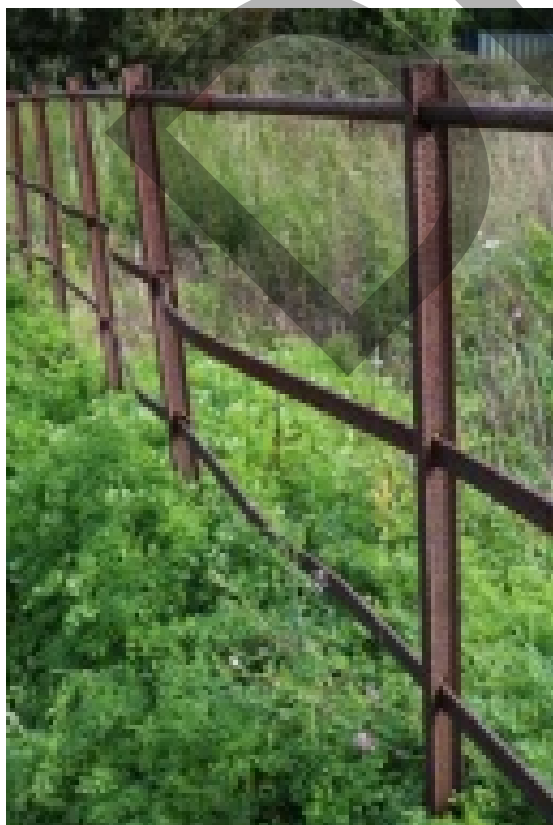
**4.9.6** Traditional metal estate fencing still survives to the southern boundary of the Recreation Ground and partially to the eastern boundary.

**Estate fencing on boundary of recreation ground**

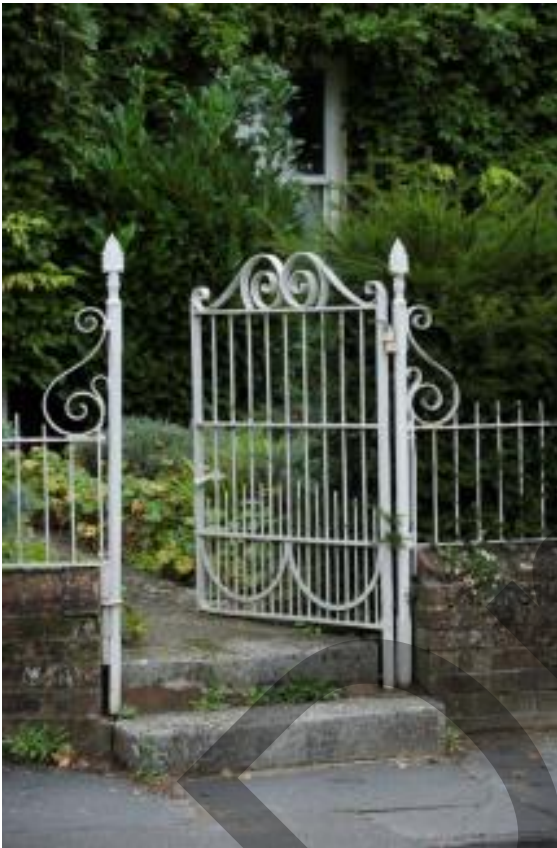
**4.9.7** There are some instances of use of decorative metal fencing and associated gates to property boundaries. Particular examples are those to Sandrock, and at Shelley Villas.

**Gate and railings at Sandrock**

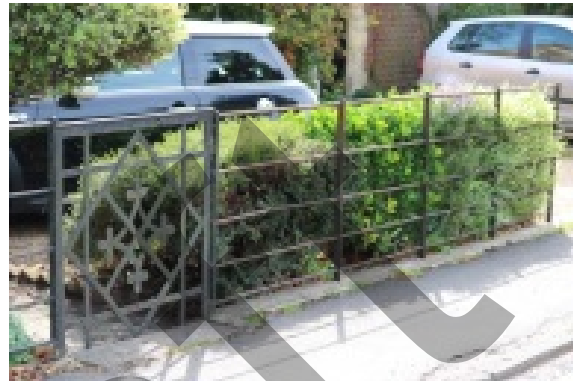
**Gate and railings at Shelley Villas**
